**Re: UPPER NORTH FORK FEATHER RIVER PROJECT, FERC NO. 2105-089
RESPONSE TO ADDITIONAL INFORMATION REQUEST**

ITEM 10: Updated Stability Analysis of Belden Dam

Subject: **Belden Forebay Rapid Drawdown Analysis**

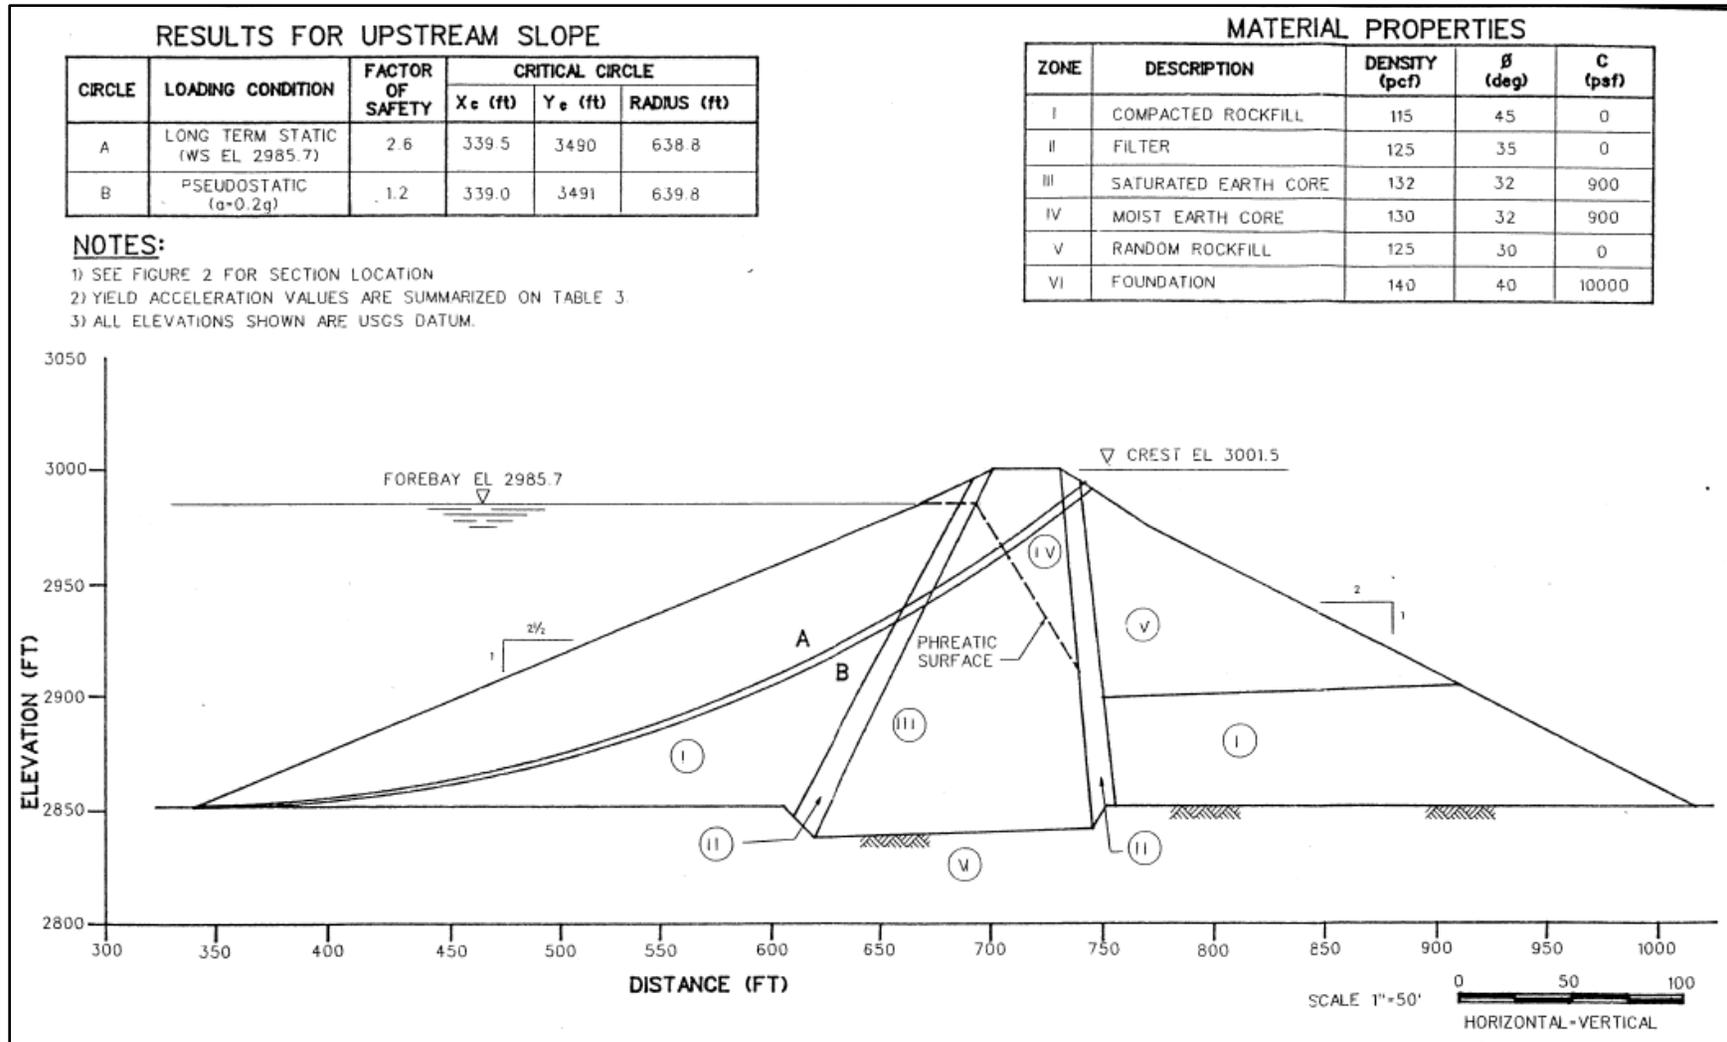
PG&E performed a static stability and seismic deformation analysis of Belden Forebay Dam in 1990 (PG&E, 1990). This analysis evaluated both upstream and downstream failure surfaces for the static and pseudo-static load cases. No analysis evaluating the stability of the upstream face during the rapid drawdown load case was performed. The normal maximum reservoir level and the dam geometry associated with the maximum section were assumed for all failure surfaces and load cases. The computer program UTEXAS2 using the Spencer method of analysis was used. The results for the upstream failure surfaces are most relevant for comparison to the updated rapid drawdown assessment presented herein and are shown in Figure 2.

Figure 2 1990 stability results for the upstream face of Belden Forebay Dam (PG&E,1990)

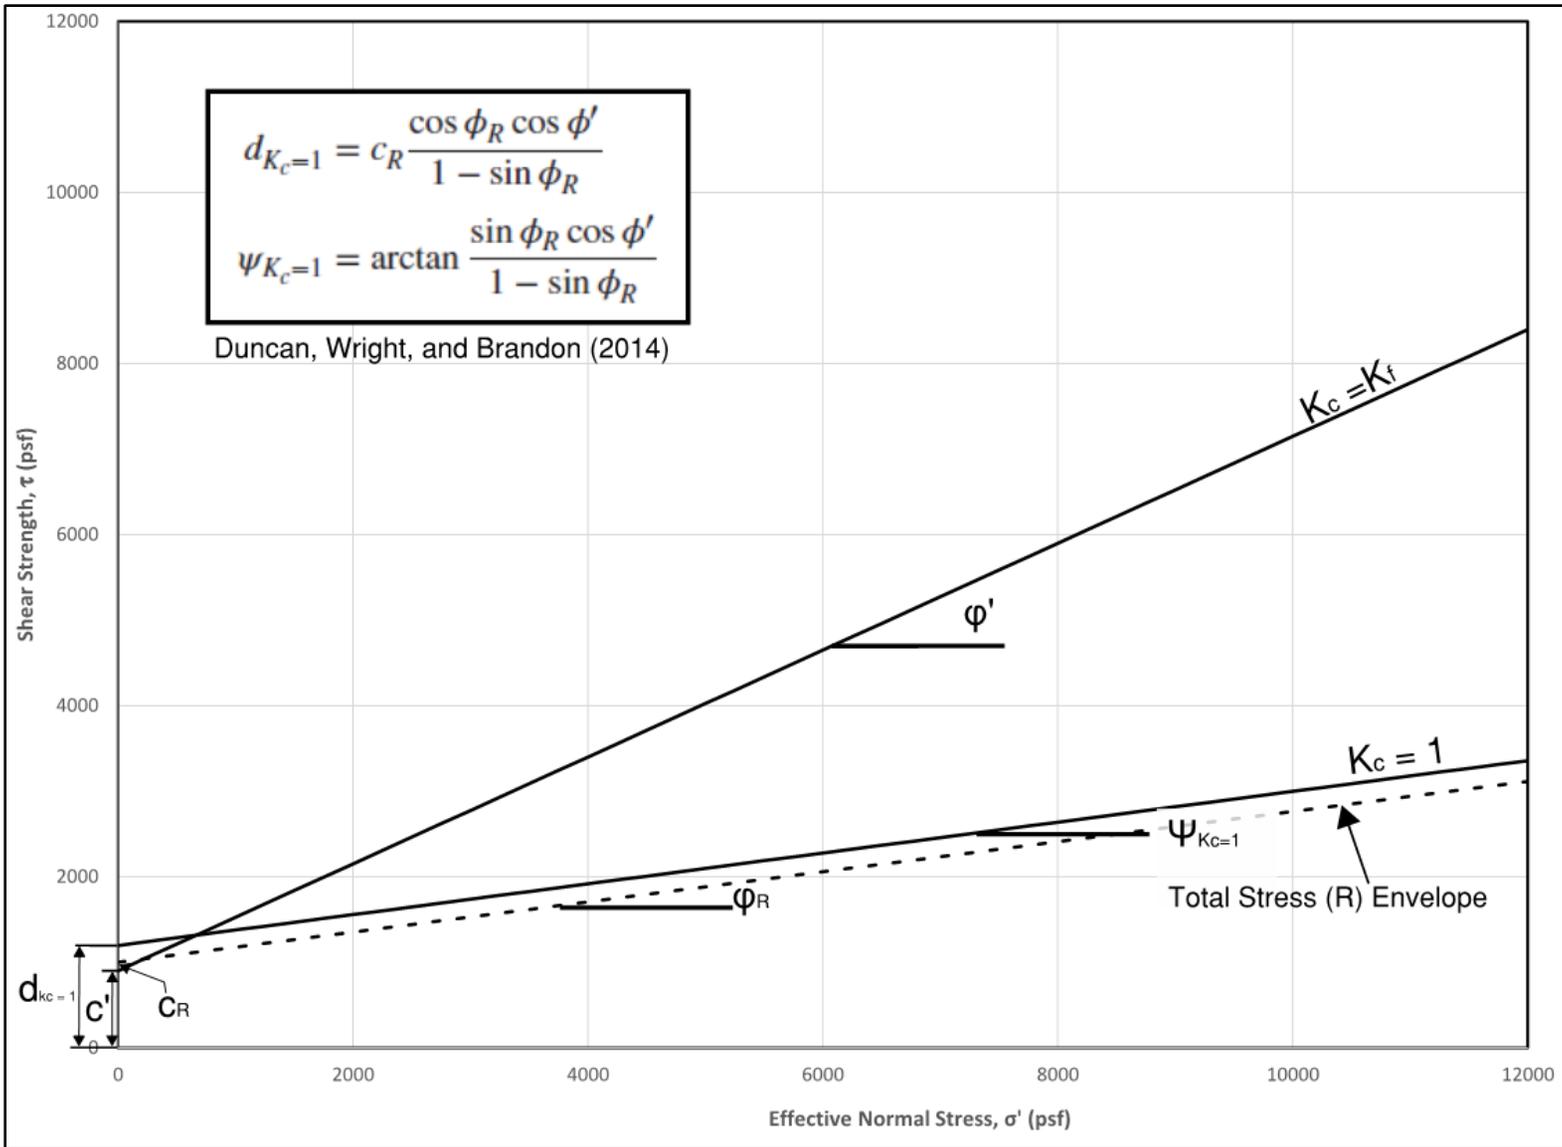
Figure 4 Strength envelopes used in the rapid drawdown stability analysis

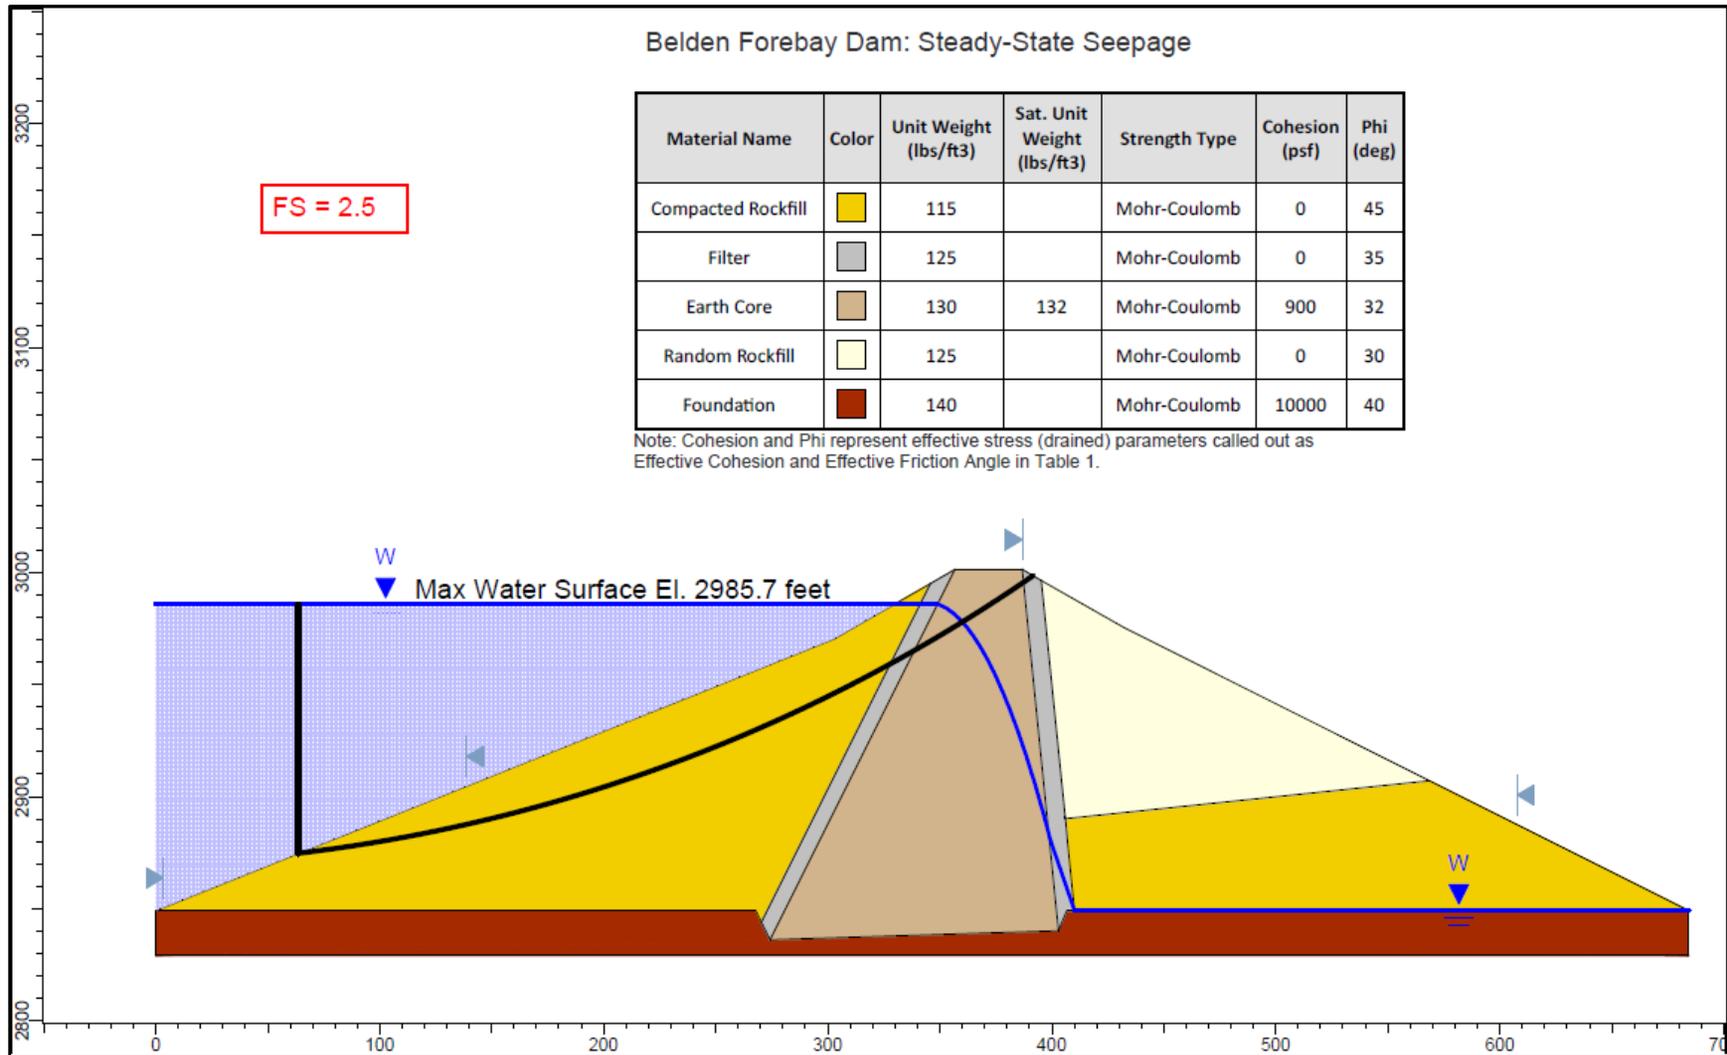
The updated slope stability evaluation for the upstream face of Belden Forebay Dam under steady-state seepage conditions is presented in Figure 5. This analysis assumes the reservoir is at the normal maximum water surface elevation of 2985.7 feet. While the predicted minimum slip surface is slightly shallower than the minimum slip surface predicted in the previous PG&E (1990) analysis, the estimated factor of safety of 2.5 is similar to the previously estimated (1990) value of 2.6. The similarity in results is expected since the dam geometry, soil properties, and loading conditions are consistent between the two analyses.

Figure 5 Stability results for upstream face of Belden Forebay Dam under steady-state seepage conditions

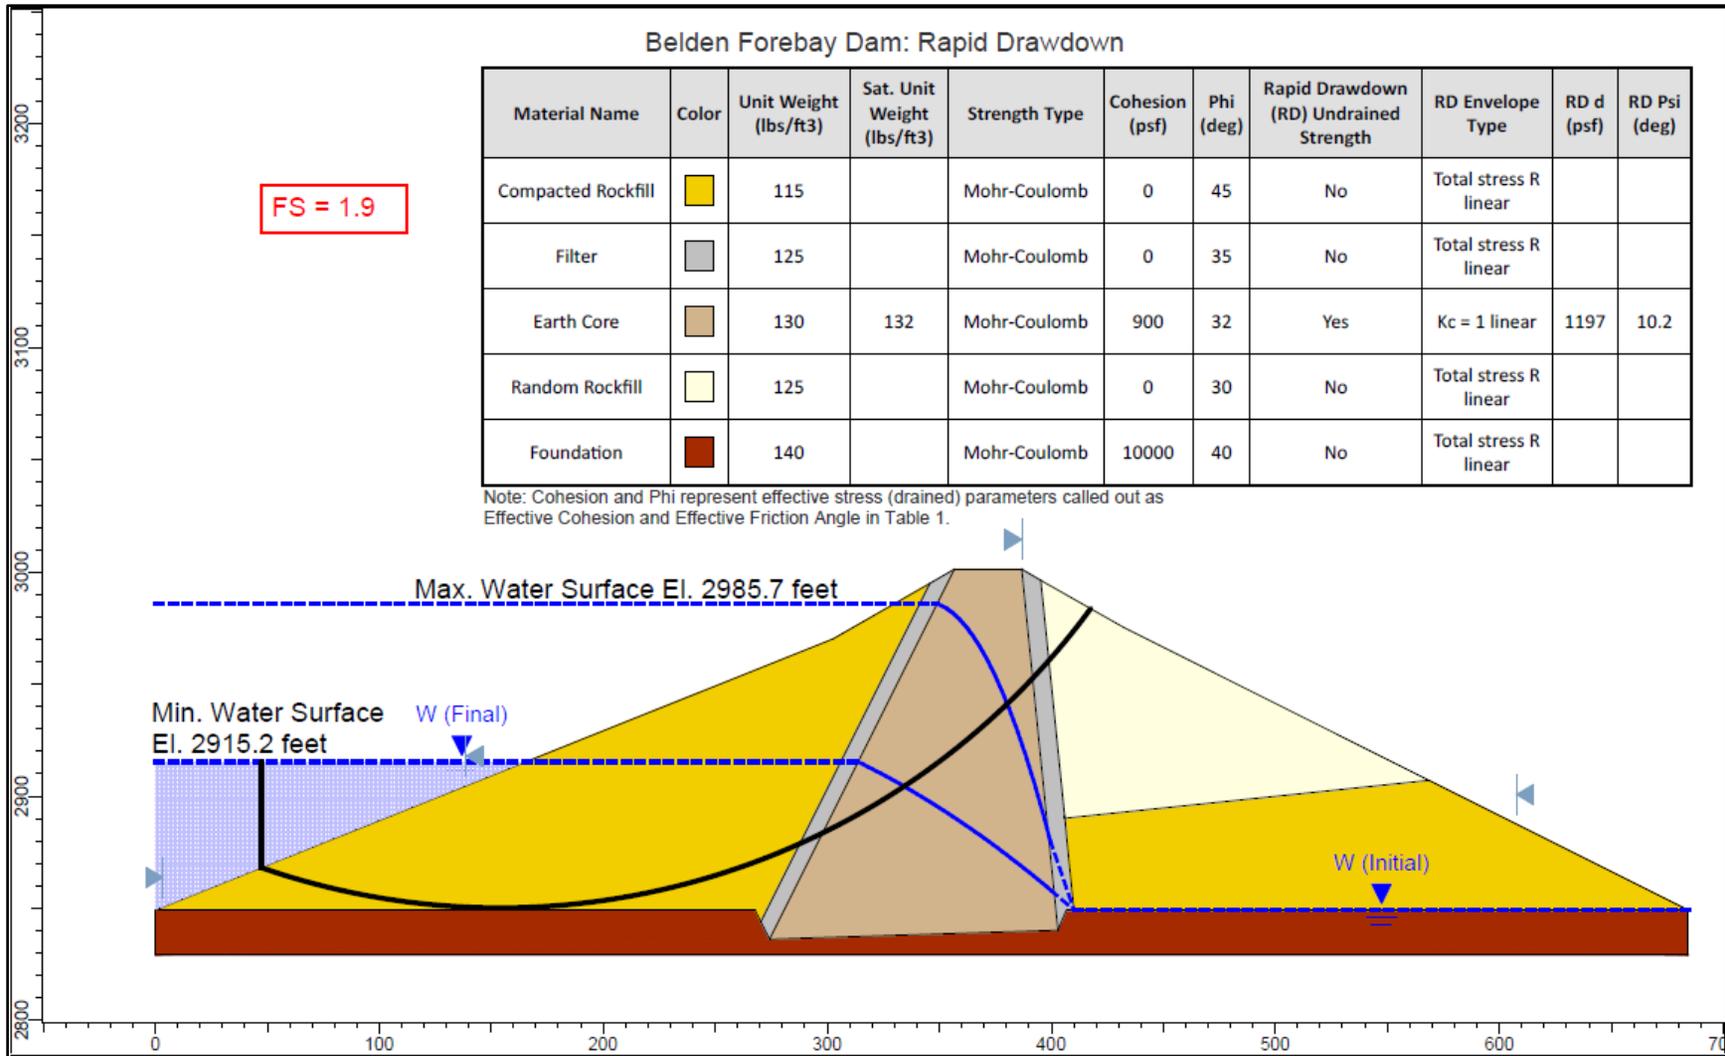
The rapid drawdown analysis using the Duncan, Wright, and Wong (1990) procedure is presented in Figure 6. The predicted minimum slip surface is deeper than that predicted for the steady-state seepage condition, extending to a depth approximately tangent with the bedrock contact and daylighting near the upstream toe of the dam. The estimated minimum factor of safety in the rapid drawdown scenario is 1.9, a reduction of approximately 25% from the steady-state seepage model. It should be noted that the intercept and slope of the total stress envelope, c_r and ϕ_r , are related but not equal to the intercept and slope of the $K_c=1$ envelope proposed in Duncan, Wright, and Wong (1990), $d_{K_c=1}$ and $\Psi_{K_c=1}$. The total stress parameters presented in Table 1 for the earth core have been converted to the corresponding $d_{K_c=1}$ and $\Psi_{K_c=1}$ values, as shown in Figure 4.

The minimum static factor of safety values computed for the upstream face of Belden Forebay Dam are summarized in Table 2. The computed factor of safety value of 1.9 for the rapid drawdown load case meets the required minimum factor of safety specified in FERC (2006) of 1.2.

Figure 6 Stability results for upstream face of Belden Forebay Dam under rapid drawdown conditions
