**ENVIRONMENTAL INSPECTION REPORT  
(ELECTRONICALLY SUBMITTED)  
FEDERAL ENERGY REGULATORY COMMISSION  
San Francisco Region**

**Inspection Dates** June 10 to 13, 2003

**Name** Upper North Fork Feather River

**Project No.** 2105-CA

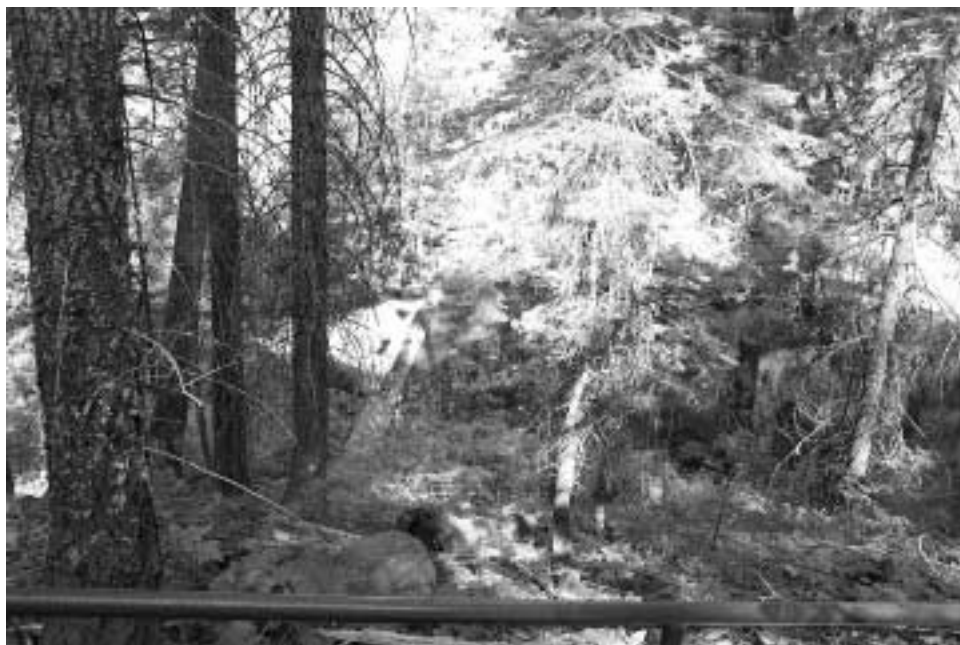
Photo 1. Control weir on North Fork Feather River below Almanor Reservoir at Gage No. NF-2.

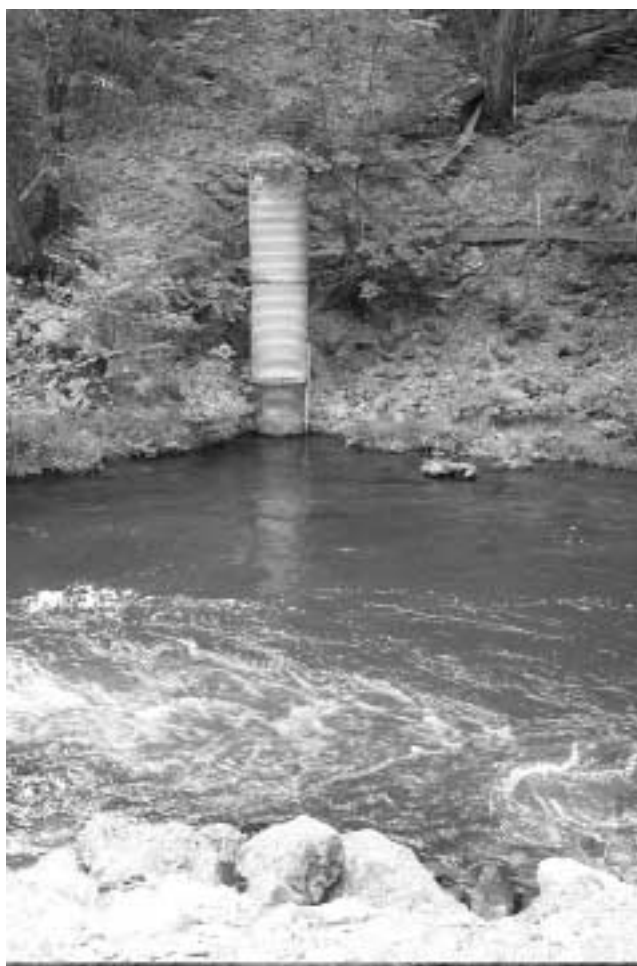
Photo 2. Gaging Station No. NF-70 on North Fork Feather River below Belden Forebay.

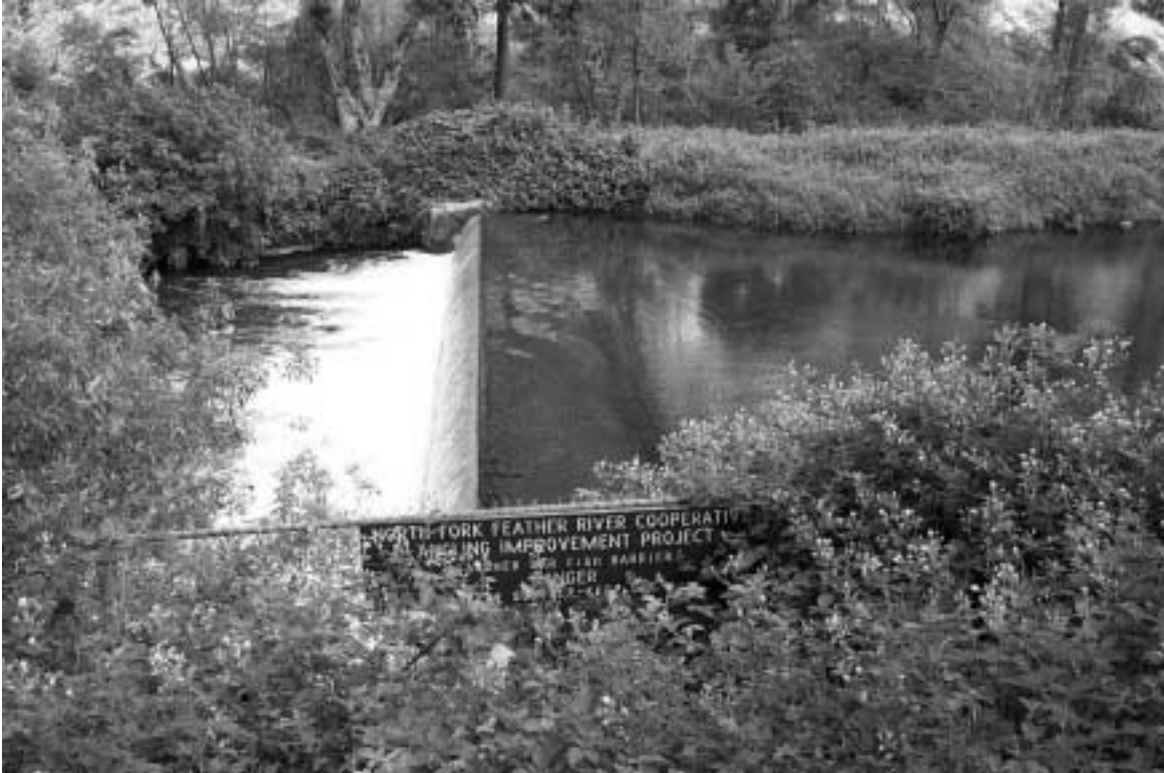
Photo 3. Gansner Bar Dam with warning sign partially obstructed by berry bushes (the licensee removed the vegetation for a clear line of sight after the inspection).

The post-inspection letter dated August 1, 2003, required 12 recreation maintenance improvements (Photos 3, 6, 9 to 11, 14, and 19 to 21). The licensee's letter dated September 30, 2003, reported that all but five items had been accomplished. Of these, two are to be done by the Forest Service this fall, replacement of the fire rings is to be done by the licensee by next spring, and the remaining two items were accomplished by the licensee on October 3, 2003, as confirmed by phone on October 15, 2003.

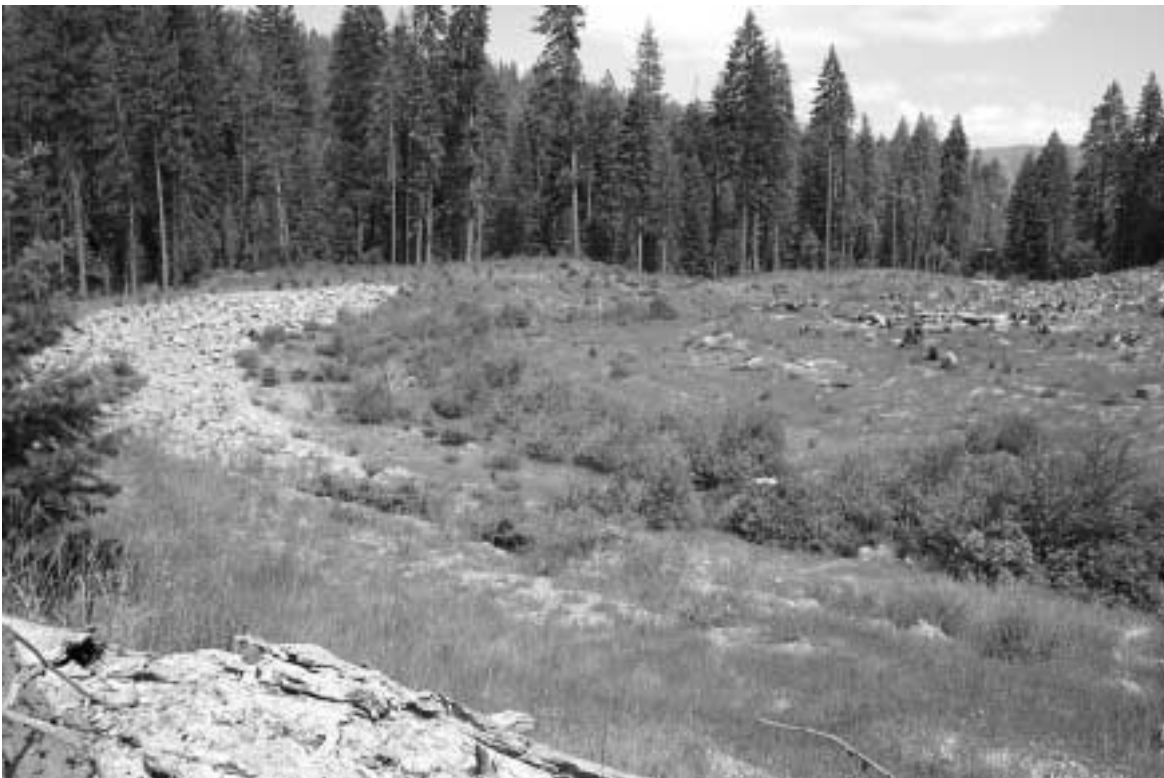
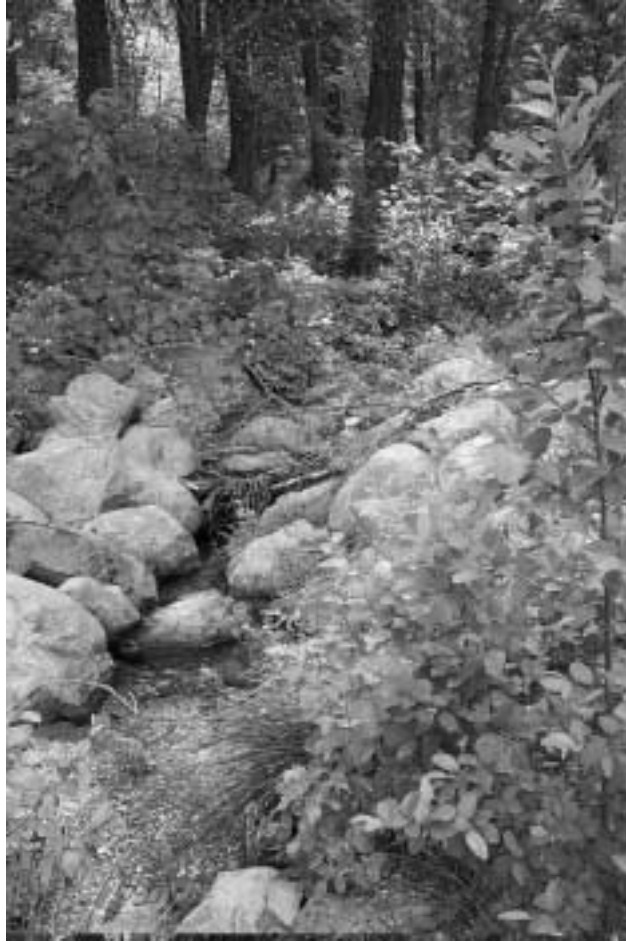
The Butt Valley Dam Remediation Biological Assessment and the Benner Creek Revegetation/Reforestation Plan specify restoration of the relocated Benner Creek channel (away from the Benner Creek borrow area) by: placement of boulders to create pool habitat; placement of 4 inches of gravel in the channel bottom; replacement of 12 inches of topsoil; planting of 350 tree and 450 shrub riparian species propagated from stock collected locally. Photos 4 and 5 show this area.

Photo 4. Benner Creek area revegetation below Butt Valley Dam.

Photo 5. Benner Creek at head of restoration area.

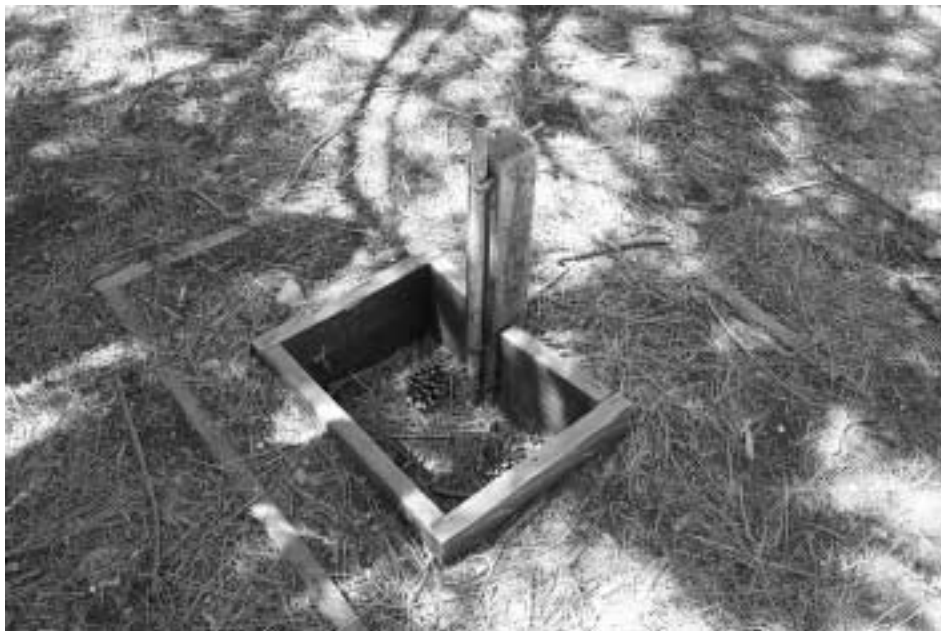
Photo 6. Well at abandoned faucet in Canyon Dam picnic area was filled in after the inspection to assure public safety.

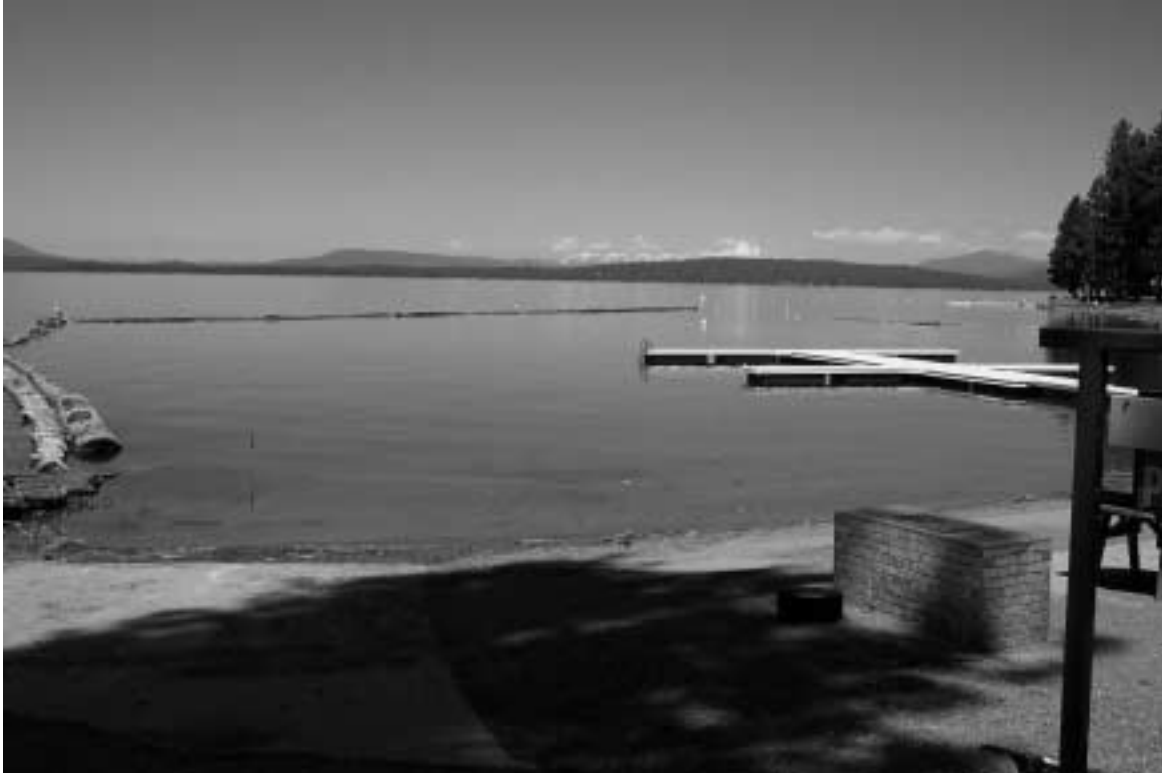
Poor visibility of floating log booms used as windbreaks at the numerous private resorts along the Lake Almanor Reservoir shoreline has been a chronic problem (as documented in previous environmental inspection (EI) reports for this project)(Photo 17). The licensee has developed public safety standards, including high visibility of these structures. As requested in the post-inspection letter dated August 1, 2003, the licensee conducted a subsequent inspection of the eight resorts with non-compliant structures identified during the EI and sent written notice to resort owners concerning needed improvements. Most visibility improvements were accomplished prior to the licensee's September 30, 2003, letter. The remaining improvements are scheduled to be completed by October 31, 2003.

Photo 7. Typical low-visibility partially sunken log booms at Lake Almanor Reservoir.

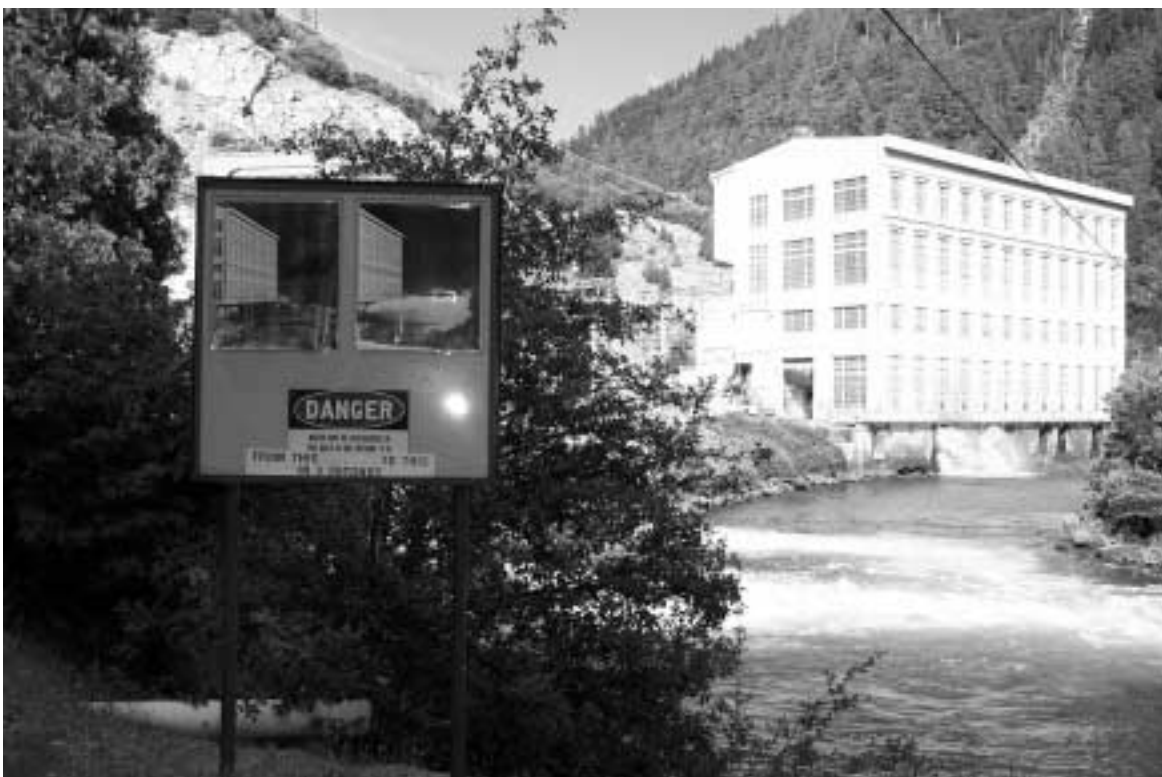
The licensee provides large sudden water fluctuation warning signs at points of public access at the Caribou Powerhouses and at the Belden Powerhouse. These include large before and after photographs of the river with the powerhouses off- and then on-line (Photo 8).

Photo 8. Sudden water fluctuation warning signs at Caribou Powerhouse with large before and after photos.

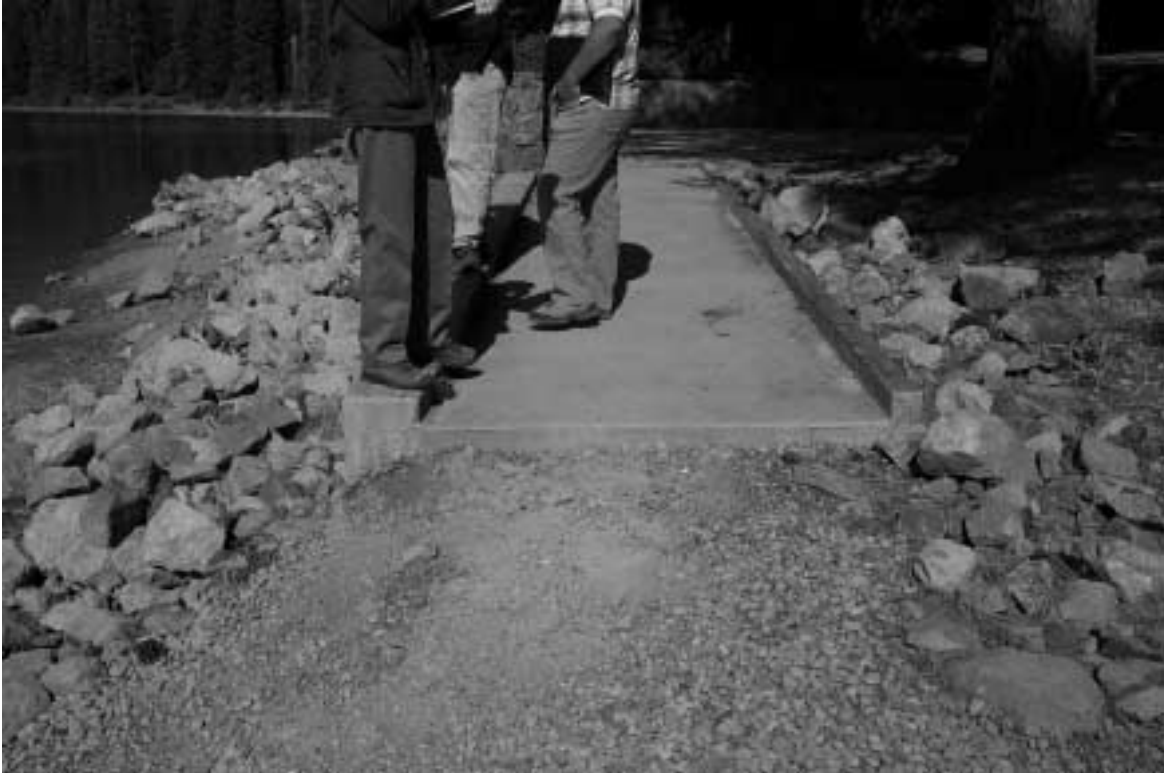
Photo 9. Lip and gravel at end of new accessible ramp at the Canyon Dam picnic area.

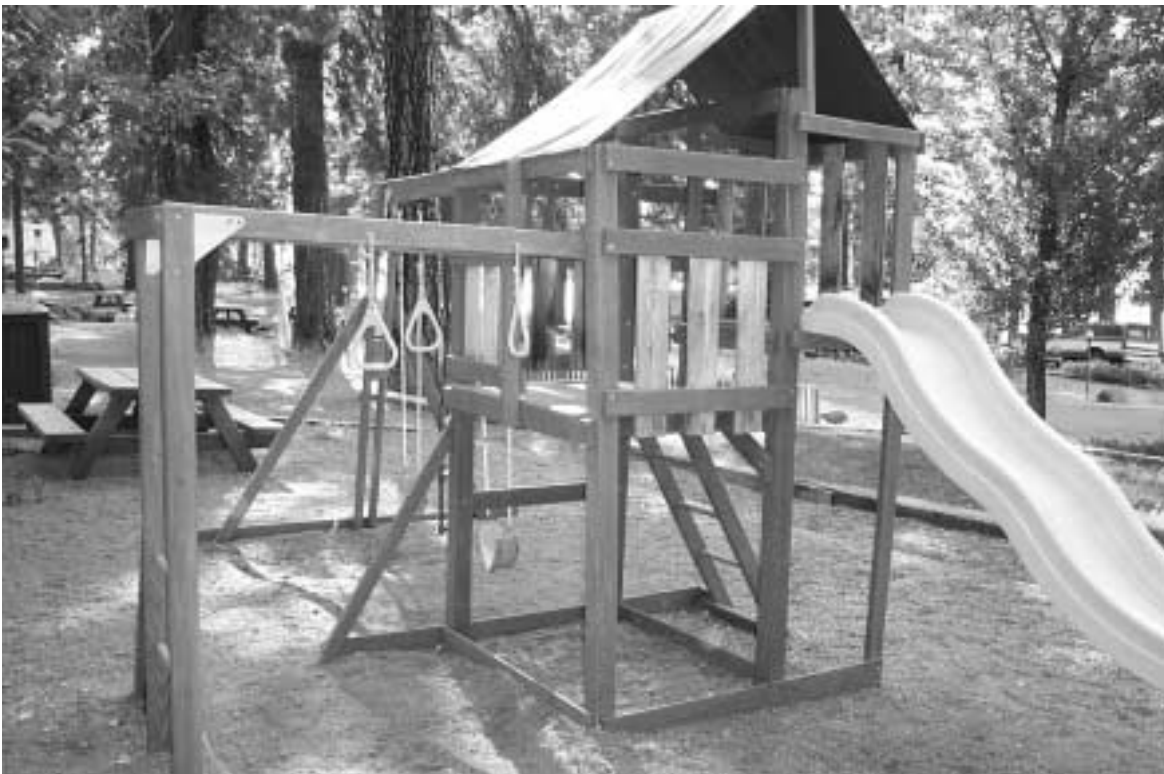
Photo 10. Child play structure at Northshore Campground had loose connections, sharp edges, and exposed bolts. It was removed after the inspection.

The licensee removed abandoned dock and old cable debris at two areas after the inspection (Photo 18) in addition to working with the operator of the Northshore Resort to remove a child play structure with sharp edges, loose connections, and protruding bolts (Photo 10).

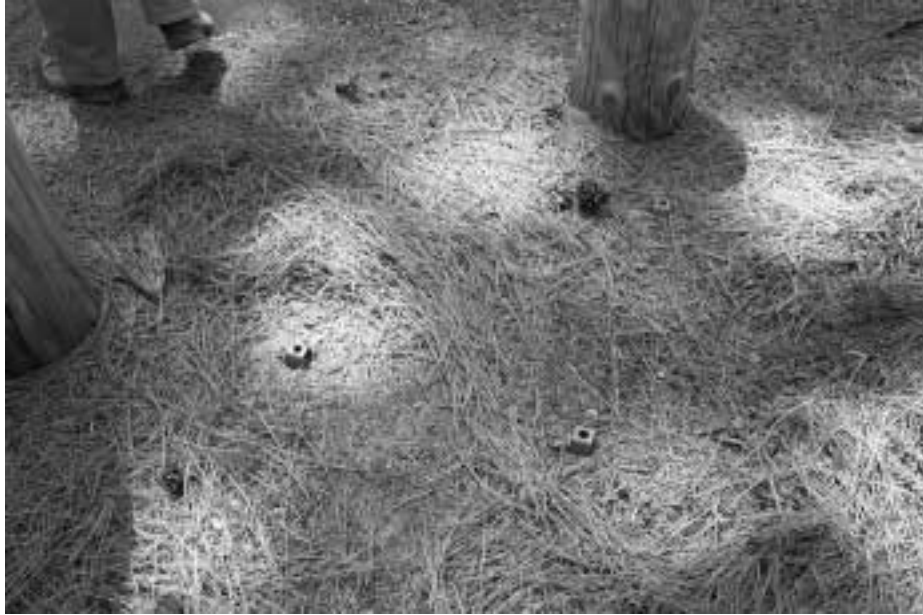
Photo 11. Abandoned trash can anchors represented a tripping hazard.

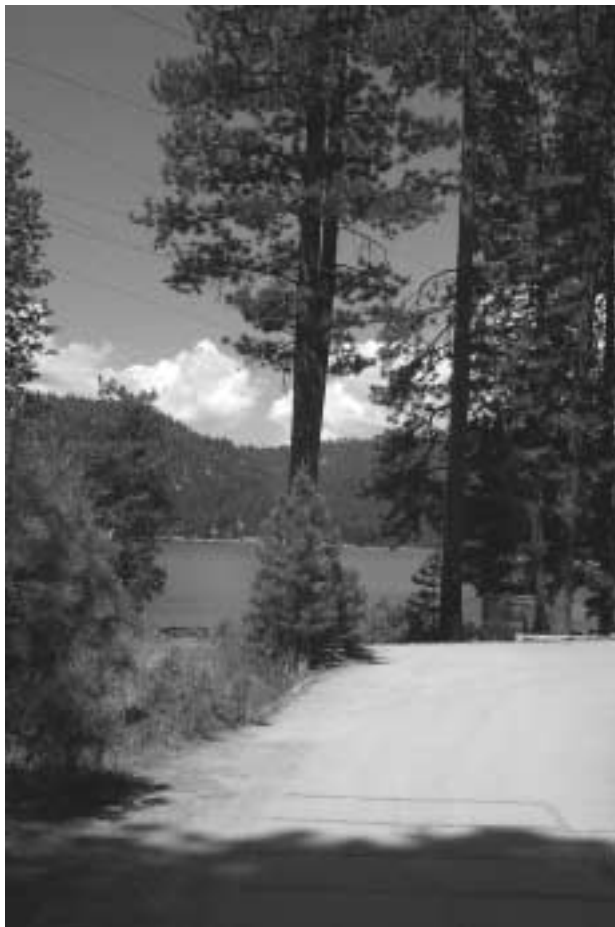
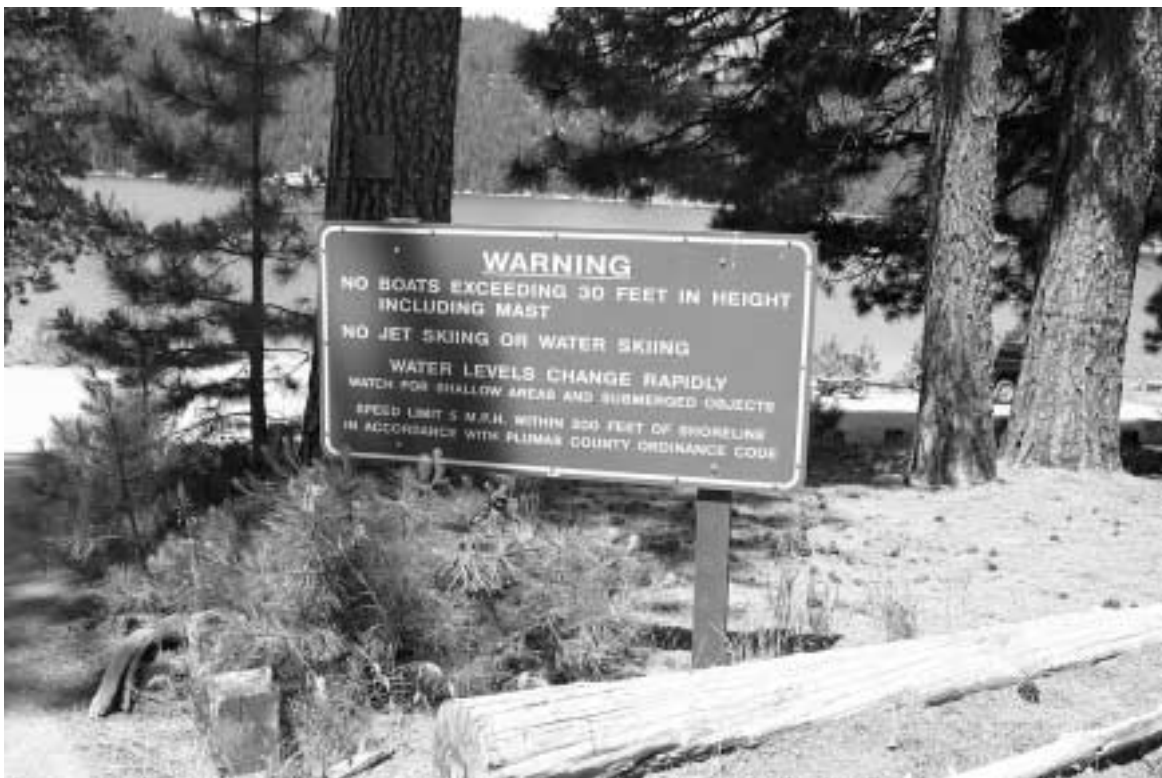
Photo 12. Access road to Alder Creek boat ramp showing transmission line clearance warning sign (brown sign in distance) located after the transmission line crossing (visible at upper left of photo).

Photo 13. Warning sign shown in Photo 12.

The licensee relocated the warning sign at the power line crossing over the Alder Creek boat launching ramp parking lot at Butt Valley Reservoir as a result of the inspection (Photos 12 and 13). The sign is now located between the main access road and the power line rather than between the line and the reservoir.

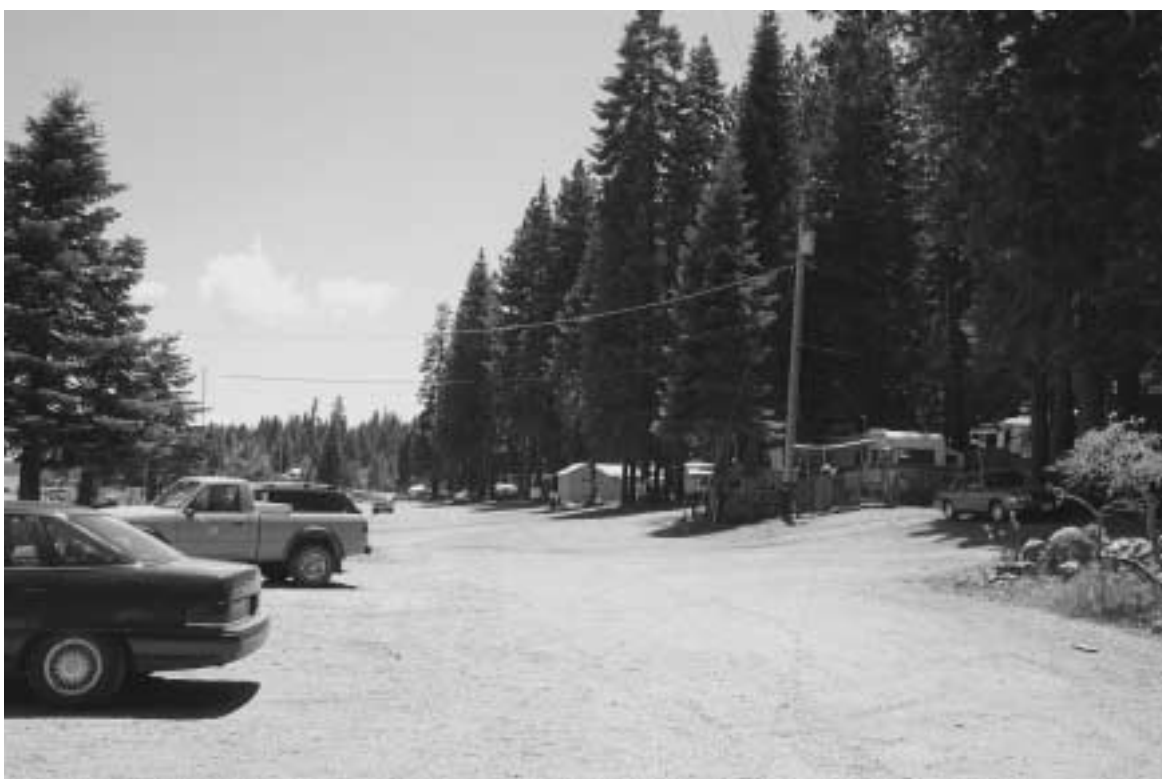
Photo 14. Power line crossing at Plumas Pines boat ramp.

The post-inspection letter dated August 1, 2003, raised the question as to whether clearance under power lines crossing over roads to boat launching ramps at Lake Almanor Reservoir was adequate. The letter required an inventory of power line crossings (Photo 14). The licensee response dated September 30, 2003, reported that 8 of the 23 crossings over roads to boat launching ramps do not meet the National Electrical Safety Code (NESC) minimum clearances. The licensee intends to raise all three of the lines that it owns where they cross the access roads. The remaining five crossings occur on lines not owned by the licensee; the owners are being identified and contacted regarding these sites.

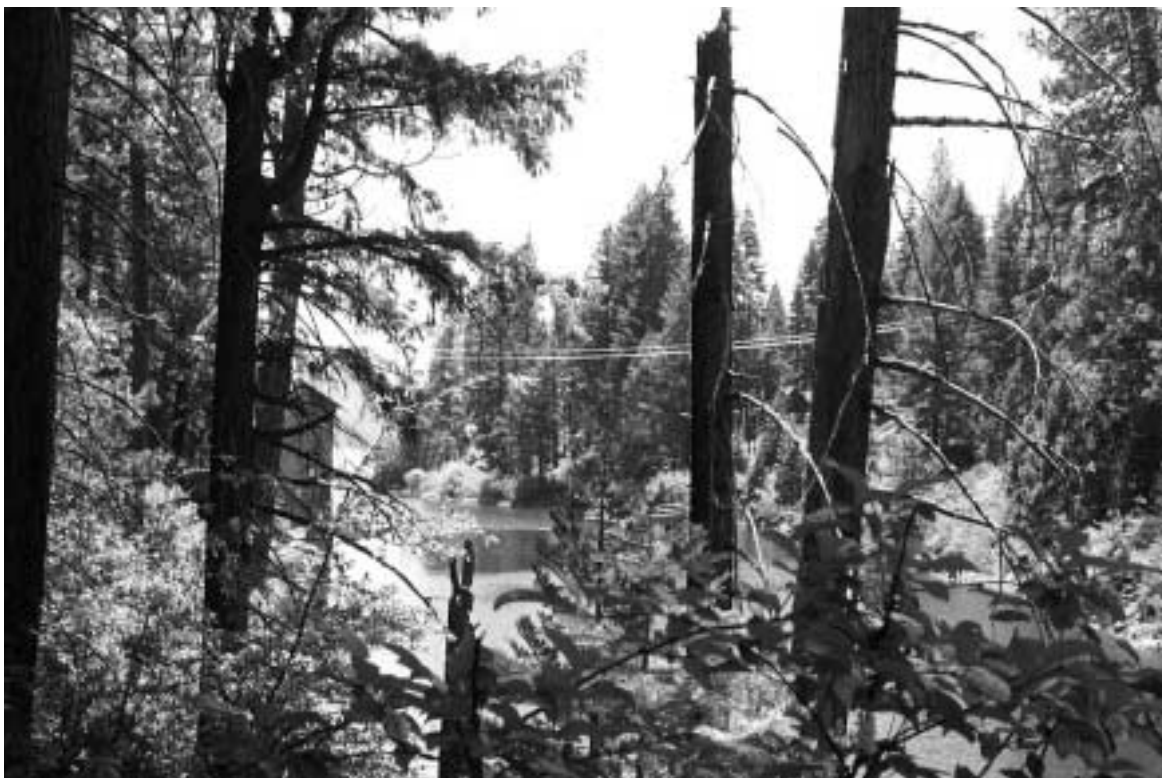
project Hamilton Branch Powerhouse across the Hamilton Branch inlet of Lake Almanor Reservoir (Photo 15). The licensee measured and reported clearance at this site that meets the NESC.

Photo 15. Transmission line crossing at Hamilton Branch Arm of Lake Almanor Reservoir is reported to meet NESC clearance requirements.

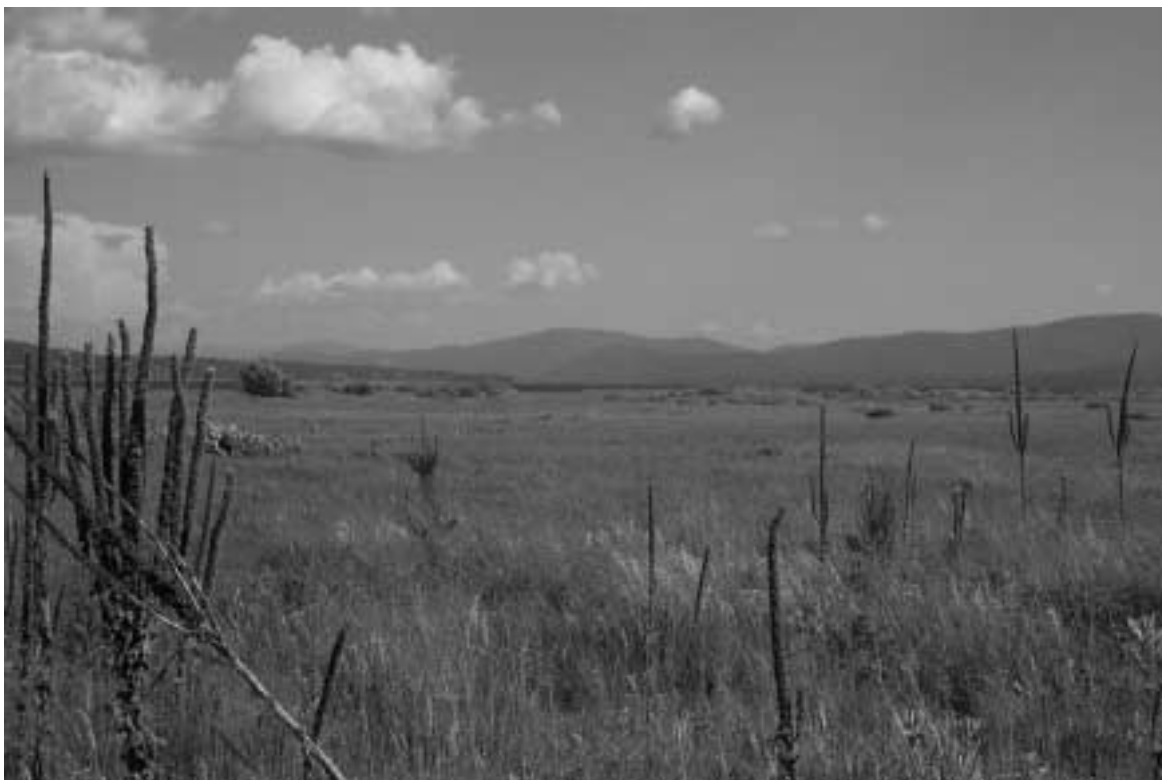
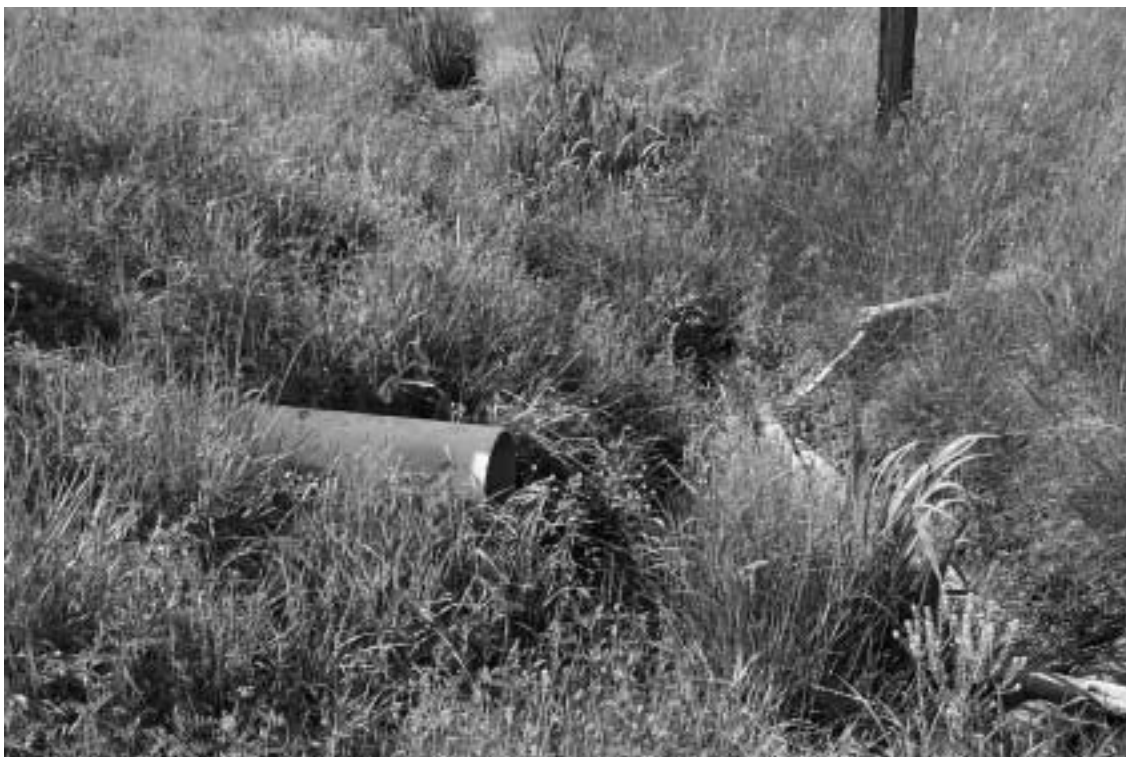
The licensee conveyed land to the Chester Public Utilities District per Order Issued May 13, 1997, for wetland treatment ponds to avoid sewage effluent discharges to Lake Almanor Reservoir. We met with Mr. Bob Merrifield with the Chester PUD during the inspection to discuss discharges. Prior to the completion of the additional ponds in 2000, the district discharged sewage effluent in 1997, 1998, 1999, and 2000. The discharges were reported to be

within the District's NPDES permit. The District reported no discharges in 2001 and 2002. Photos 16 and 17 show a new wetland pond and the outfall at a drainage ditch leading to Lake Almanor Reservoir.

Photo 16. Wetland pond at Chester PUD treatment plant.

Photo 17. Outfall from wetland pond to drainage ditch that discharges to Lake Almanor Reservoir.

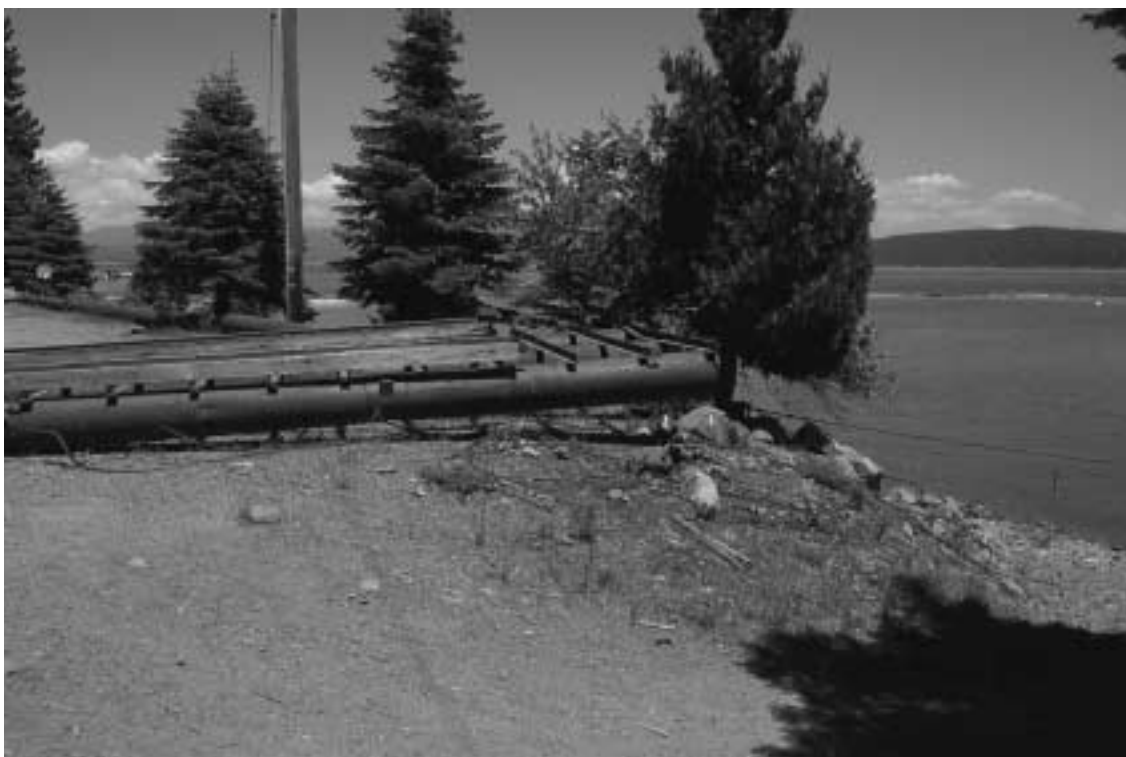
Photo 18. Debris at Plumas Pines Resort was removed after the inspection.

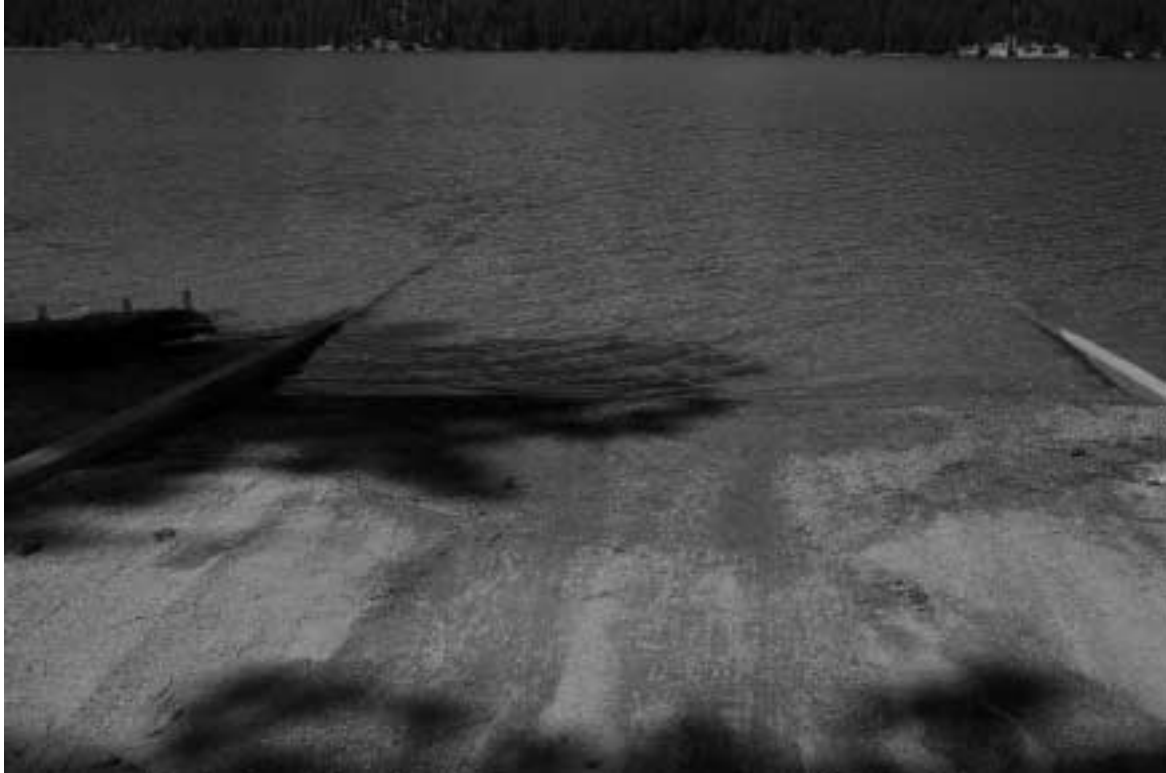
Photo 19. Sediment on the Alder Creek boat launching ramp was removed after the inspection.

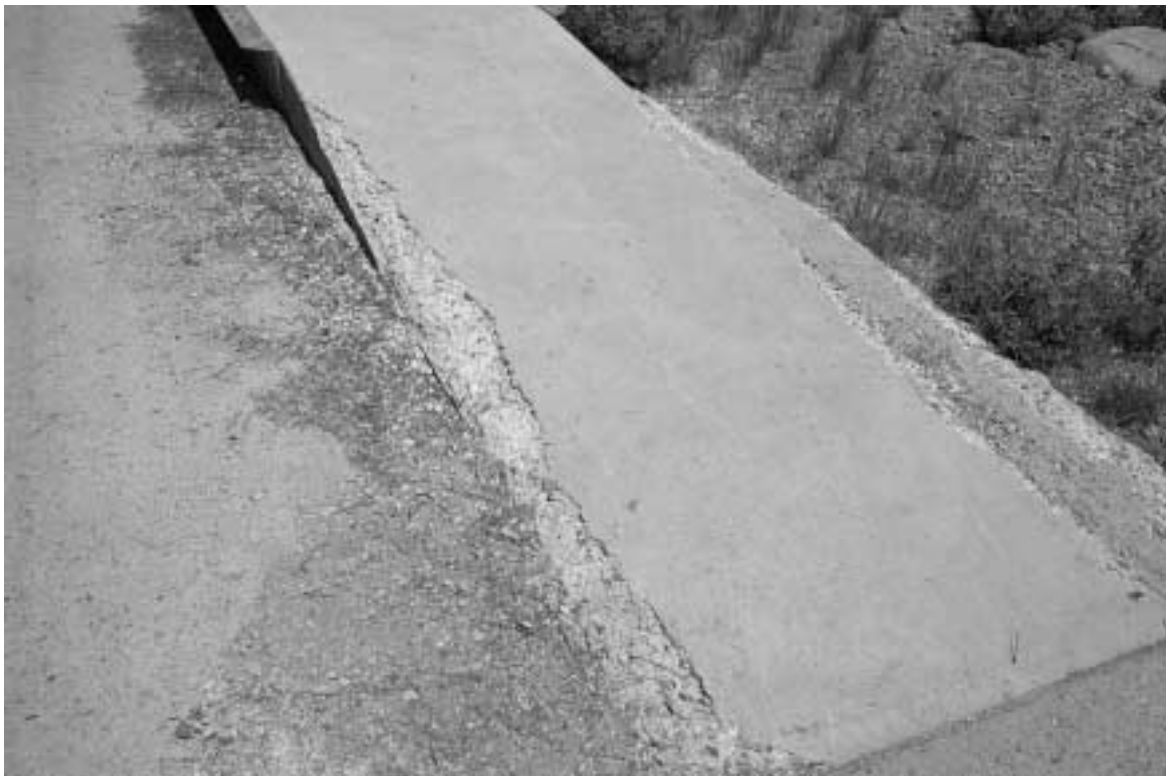
Photo 20. Spalled concrete at the Almanor Campground boat launching ramp.

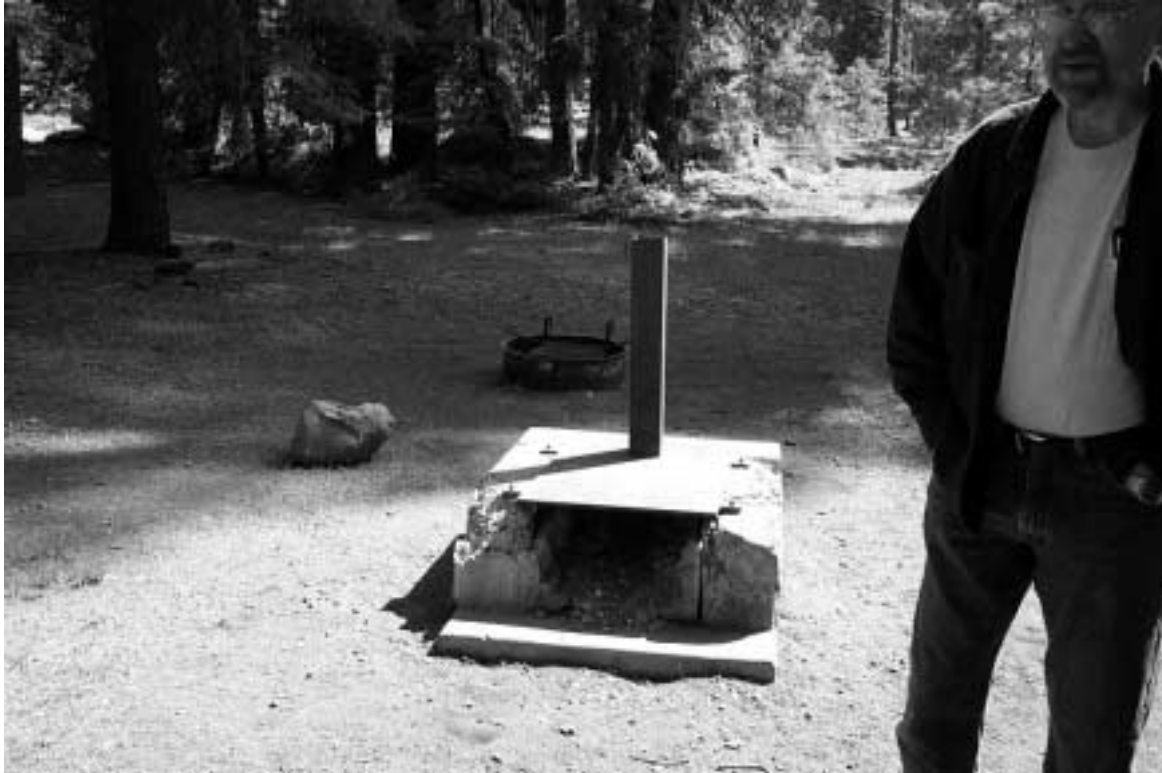
Photo 21. Deteriorated Klamath stoves will be replaced by the next recreation season.

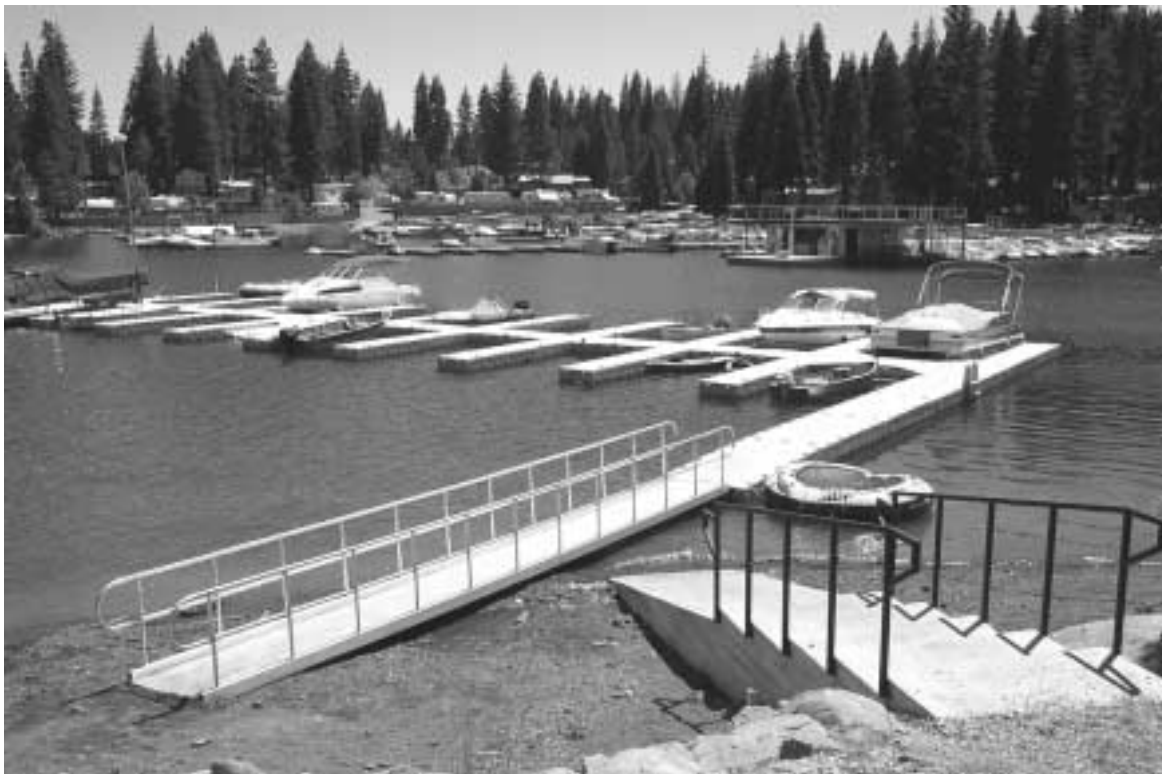
The inspection noted congestion on the water surface in the Big Cove area of Lake Almanor Reservoir due to extensive private development in a narrow inlet (Photo 22). Private resorts located in the Big Creek Arm of Lake Almanor Reservoir include the following listed in counterclockwise order from the northeast portion of the inlet:

Photo 22. Congested Big Cove Arm of Lake Almanor Reservoir as seen from the newly installed 20 slips of the Almanor Lakefront Village.

The post-inspection letter requested notification of how the licensee intended to address the overcrowding issue. The letter also noted that the current permit program for Lake Almanor Reservoir does not include criteria for assessing the appropriate level of development based on planning concepts such as Boats-At-One-Time (BAOT) capacity, physical constraints, environmental considerations, and public safety concerns. The licensee responded in its letter dated September 30, 2003, that it would consult with marina operators and the Plumas County Sheriff's Boat Patrol to develop measures to be implemented in 2004, with a follow-up report on the results of this effort to be filed with FERC.

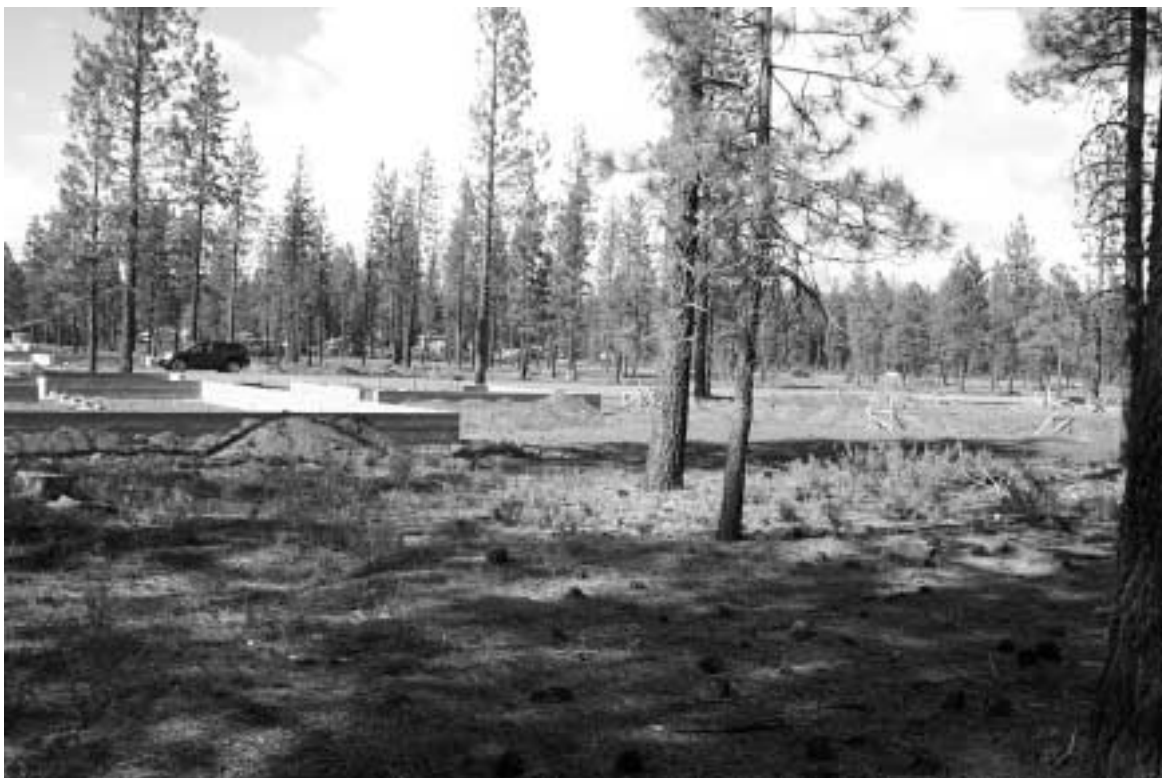
At the time of inspection, a developer had begun construction of a subdivision with some lots below the high water line of Lake Almanor Reservoir (Photo 23). The post-inspection letter dated August 1, 2003, requested additional information and stated that residential development should not occupy project lands, especially when such development would preclude project operations such as filling the reservoir to the spillway crest elevation. The letter also cited Article 42 (control of non-project uses of project lands) and Article 17 (reasonable public access for recreation). The licensee responded by letter dated September 30, 2003. Construction on project lands at Vision Lake Homes has been halted pending negotiations with the developer. The licensee will file an amendment application for Commission approval once a compromise has been worked out. Work will not resume at the lots within the project boundary until the Commission acts on the application.

Photo 23. Vision Lake Homes subdivision under construction as of the inspection.

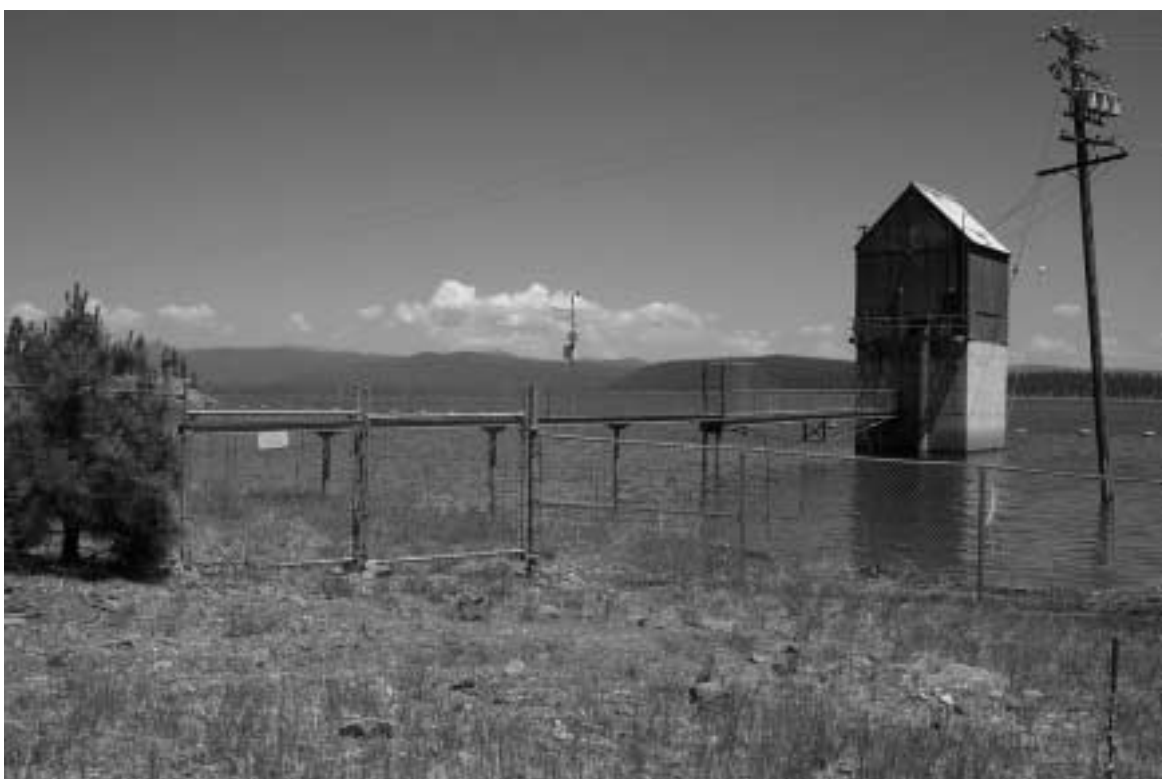
Photo 24. Prattville Intake in Lake Almanor Reservoir. Note public exclusion safety fencing.

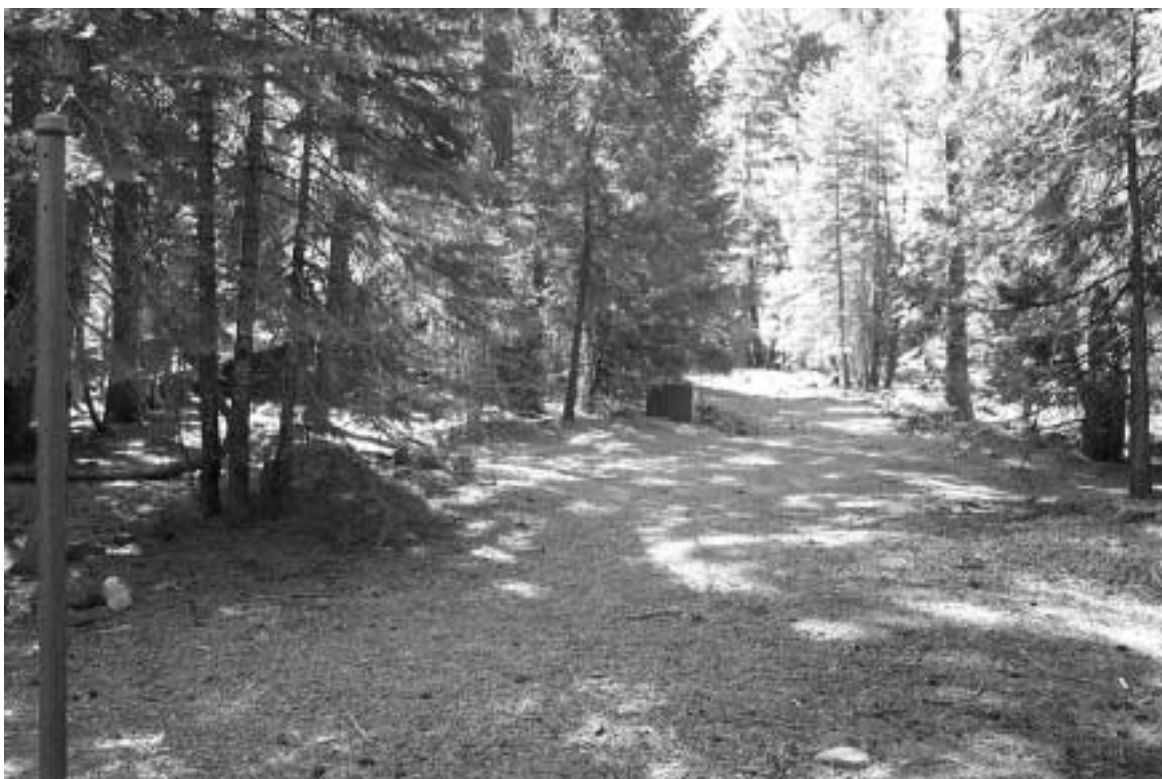
Photo 28. Possible future expansion area at Camp Connery Group Camp.

Preliminary proposals for new public recreation sites at the project that may be considered during relicensing efforts include ten sites at Lake Almanor Reservoir, three dispersed or trail sites at Butt Valley Reservoir, and one cartop launch at the Belden Forebay (Photos 28 and 32 to 34). A long unpaved road that crosses railroad tracks provides difficult access to the Catfish Beach site.
