**ENVIRONMENTAL INSPECTION REPORT  
(ELECTRONICALLY SUBMITTED)  
FEDERAL ENERGY REGULATORY COMMISSION  
San Francisco Region**

**Inspection Dates** June 10 to 13, 2003

**Name** Upper North Fork Feather River

**Project No.** 2105-CA

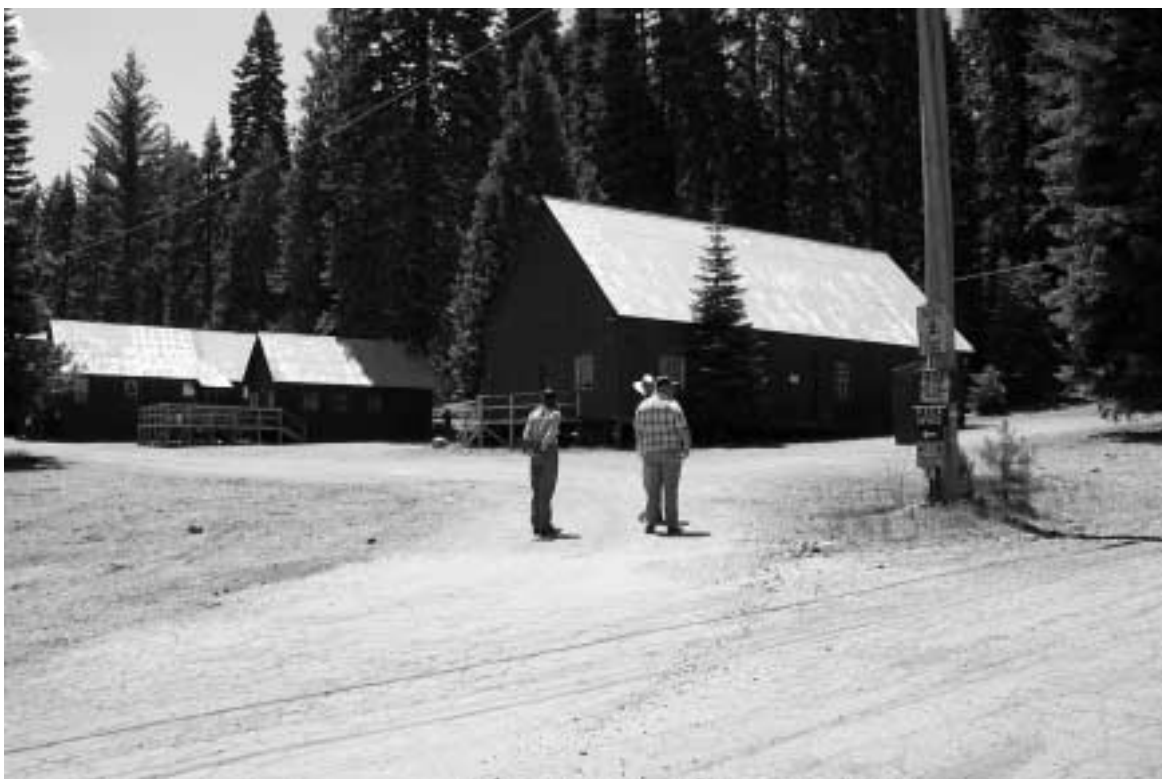
Photo 30. Pacific Service Employees Association Camp Almanor.

Prattville intake)(Photo 30) and Camp Sun Ray (near Canyon Dam)(Photo 31). Both are located back away from the Lake Almanor Reservoir shoreline. When a new license is issued, either (1) these areas should be opened to the general public, instead of being open only to licensee staff and their friends/family, and a length of stay limit should be imposed consistent with restrictions at other public recreation sites at the reservoir, or, (2) the project boundary should be redrawn to exclude these private developments.

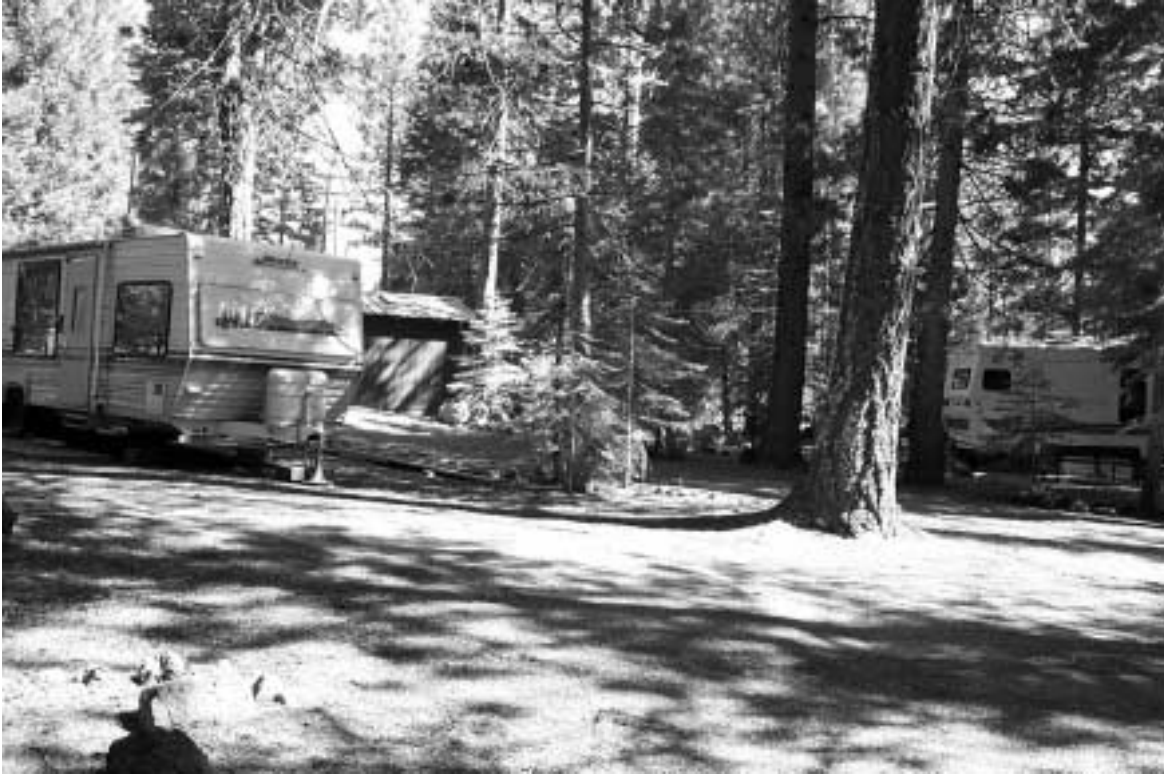
Photo 31. Pacific Service Employees Association Camp Sun Ray.

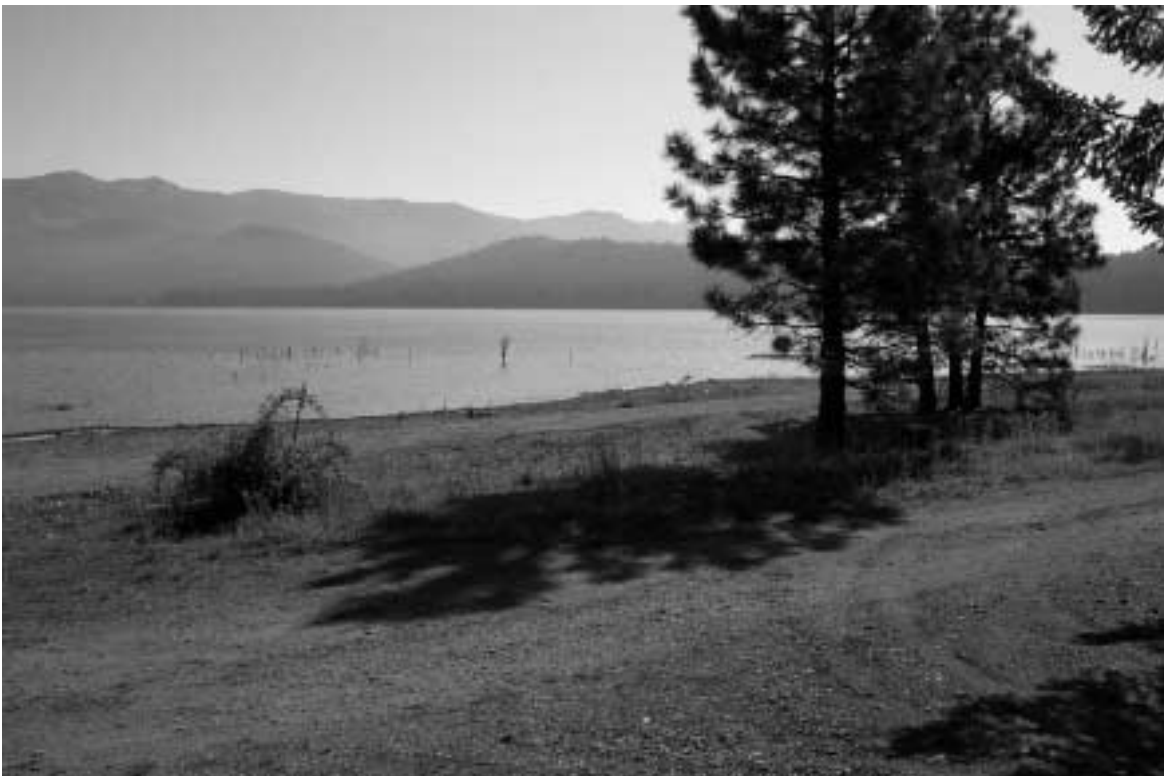
Photo 32. Typical dispersed use area with informal roads along the southwest shore of Lake Almanor Reservoir under consideration as recreation access area during relicensing.

Preliminary proposals for new public recreation sites at the project that may be considered during relicensing efforts include ten sites at Lake Almanor Reservoir, three dispersed or trail sites at Butt Valley Reservoir, and one cartop launch at the Belden Forebay (Photos 28 and 32 to 34). A long unpaved road that crosses railroad tracks provides difficult access to the Catfish Beach site.

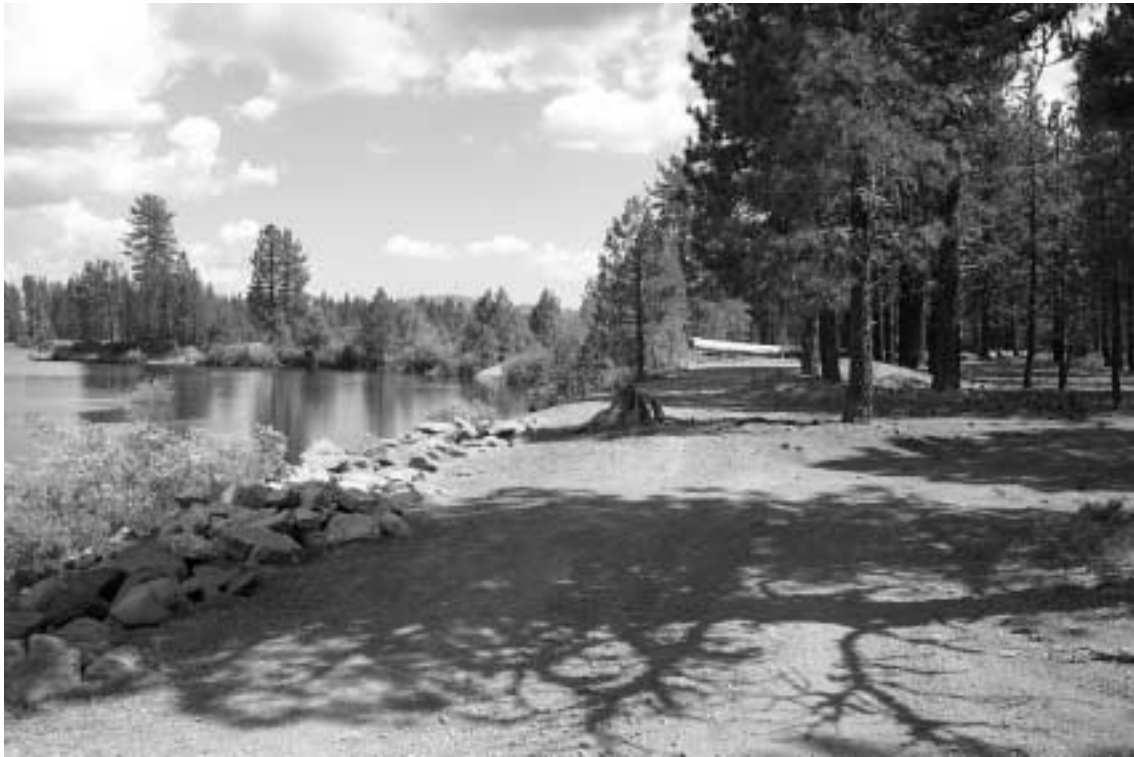
Photo 33. Possible shoreline access area near the super ditch (flood control feature at Chester, California) where it discharges to Lake Almanor Reservoir.

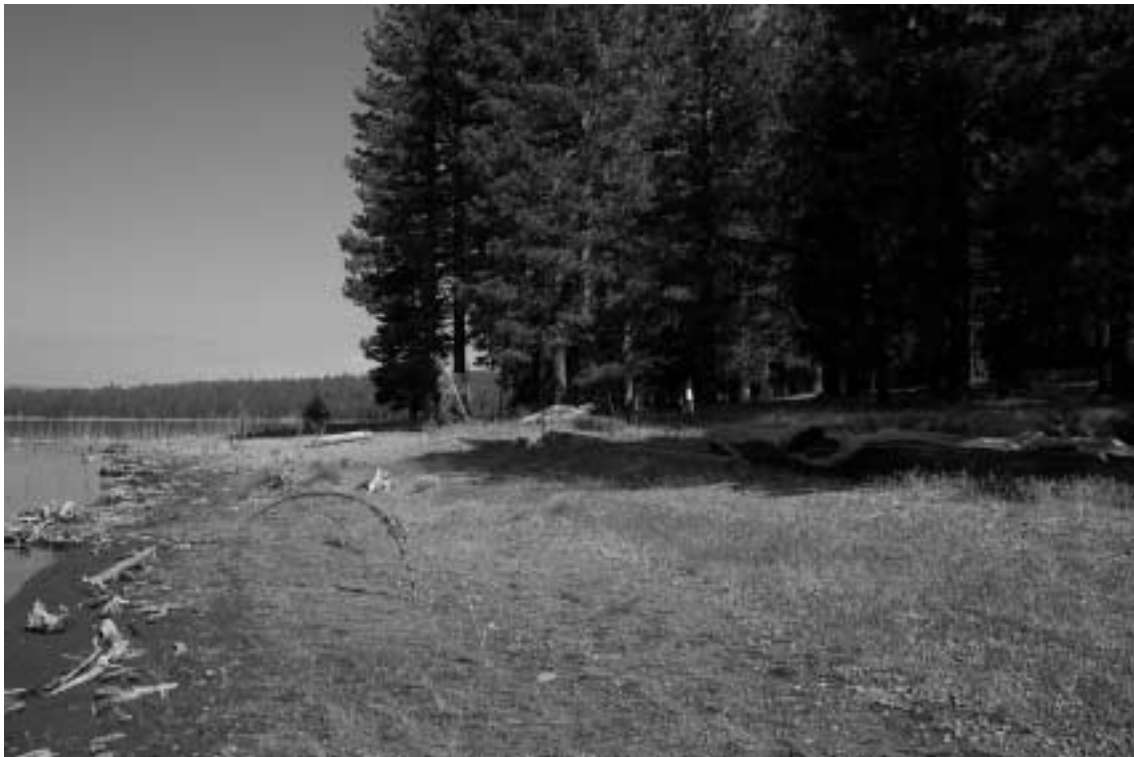
Photo 34. Possible future recreation site at Catfish Beach on Lake Almanor Reservoir.
